Catastrophic aluminium-alloy dust explosion in China in 2014

Section 7.4.9 in Rolf K. Eckhoff: «Explosion hazards in the process industries» 2nd Ed. (2016)

Rolf K. Eckhoff, Dept. Physics and Technology, University of Bergen, Norway

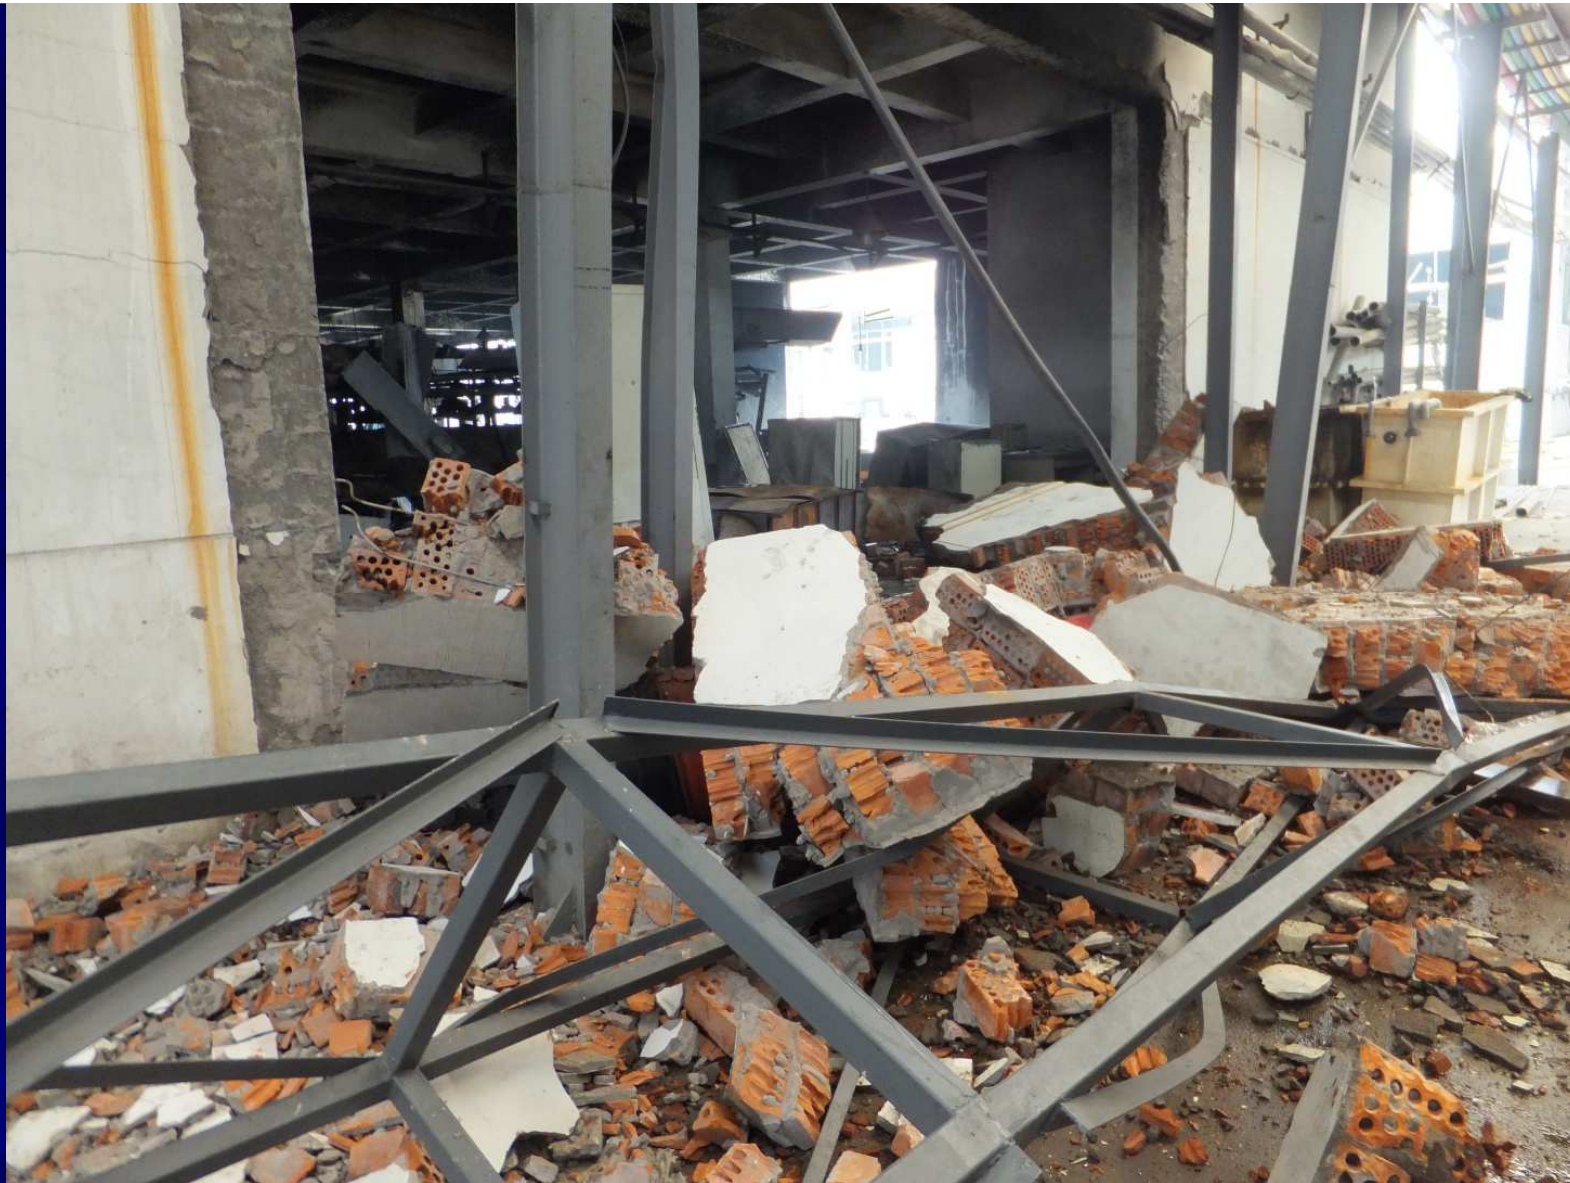
- These 8 explosions could be identified on the video recording as violent “mushroom-shaped” dust/smoke clouds being expelled abruptly from each of the 8 dust collectors. All the windows in the first floor of the building that exploded were shattered and blown to the outside, and the window frames were completely deformed. Two thirds of the southern wall of the building collapsed.

Figure 7-59. Collapsed and destroyed eastern wall and air conditioner. From Li et al. (2016)

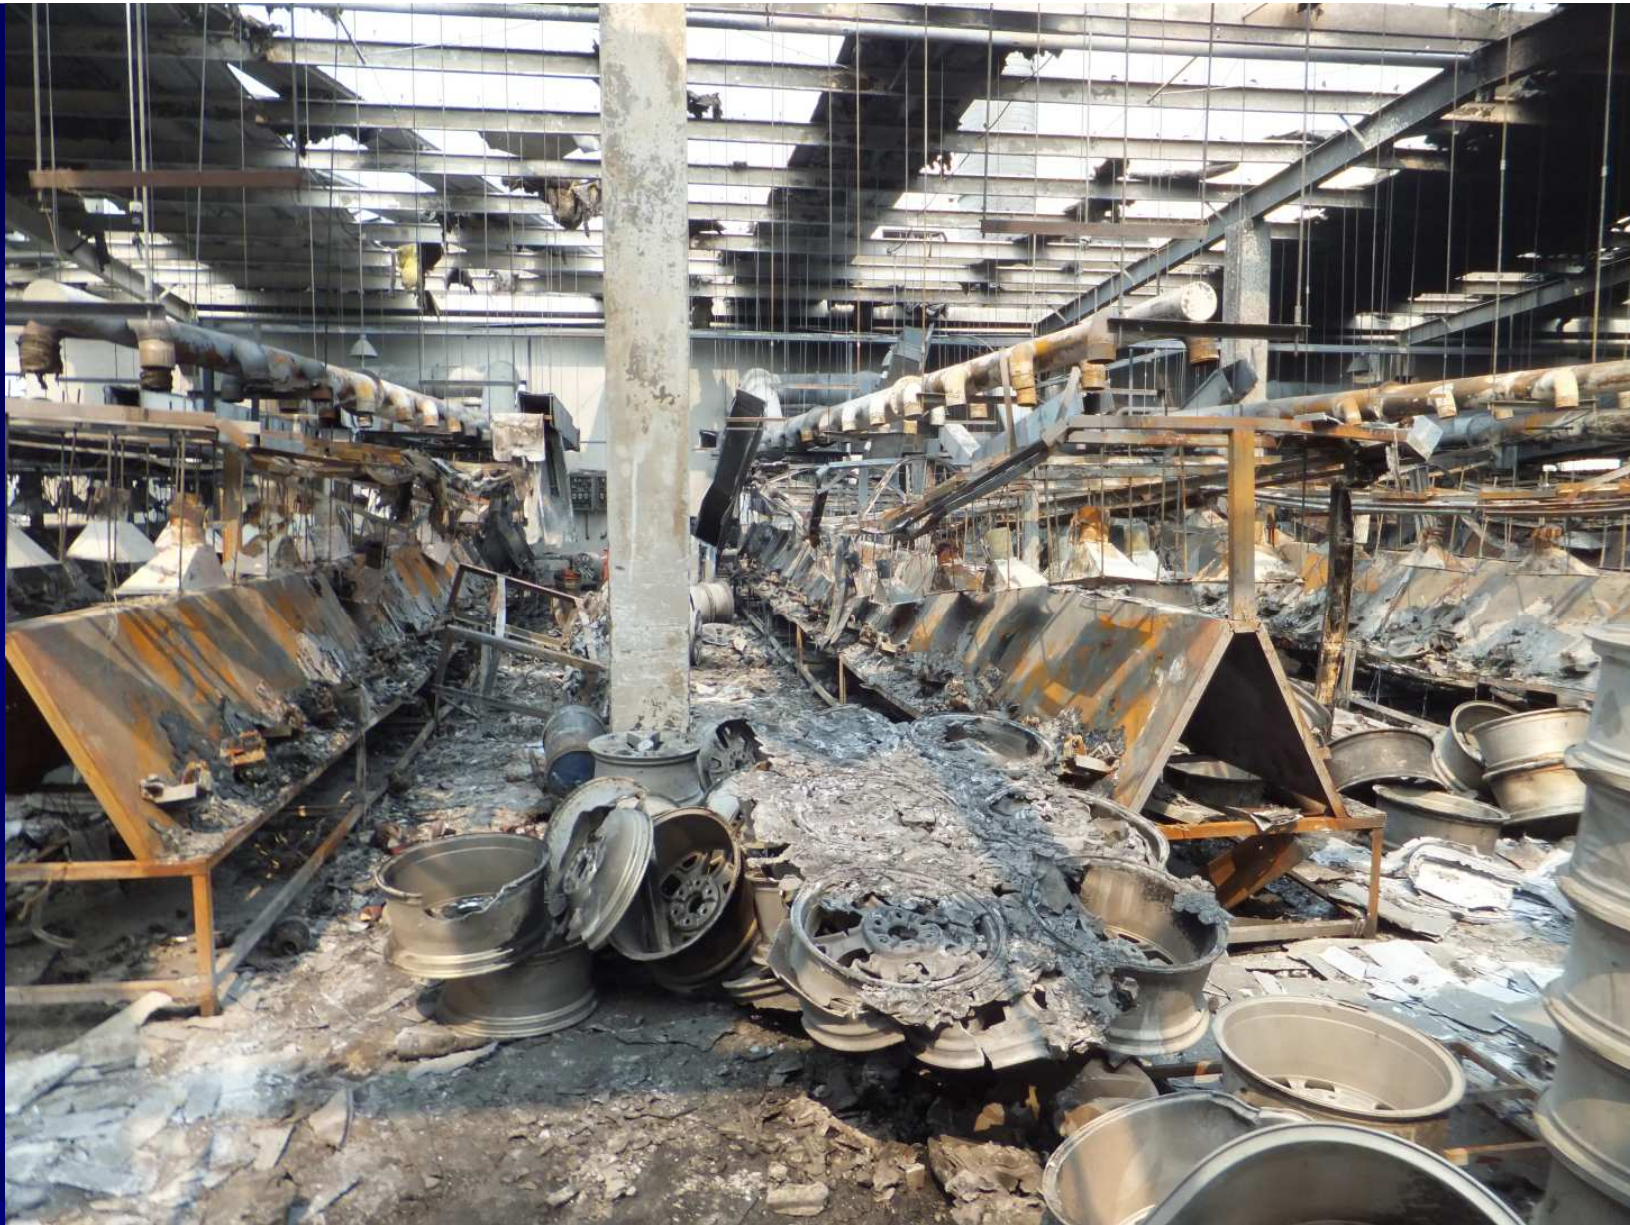
- Almost all process equipment in the workshop was destroyed. **Figure 7-60** shows the total damage of the process lines on the second floor.

**Figure 7-60. Destroyed process lines on the second floor.
From Li et al. (2016)**

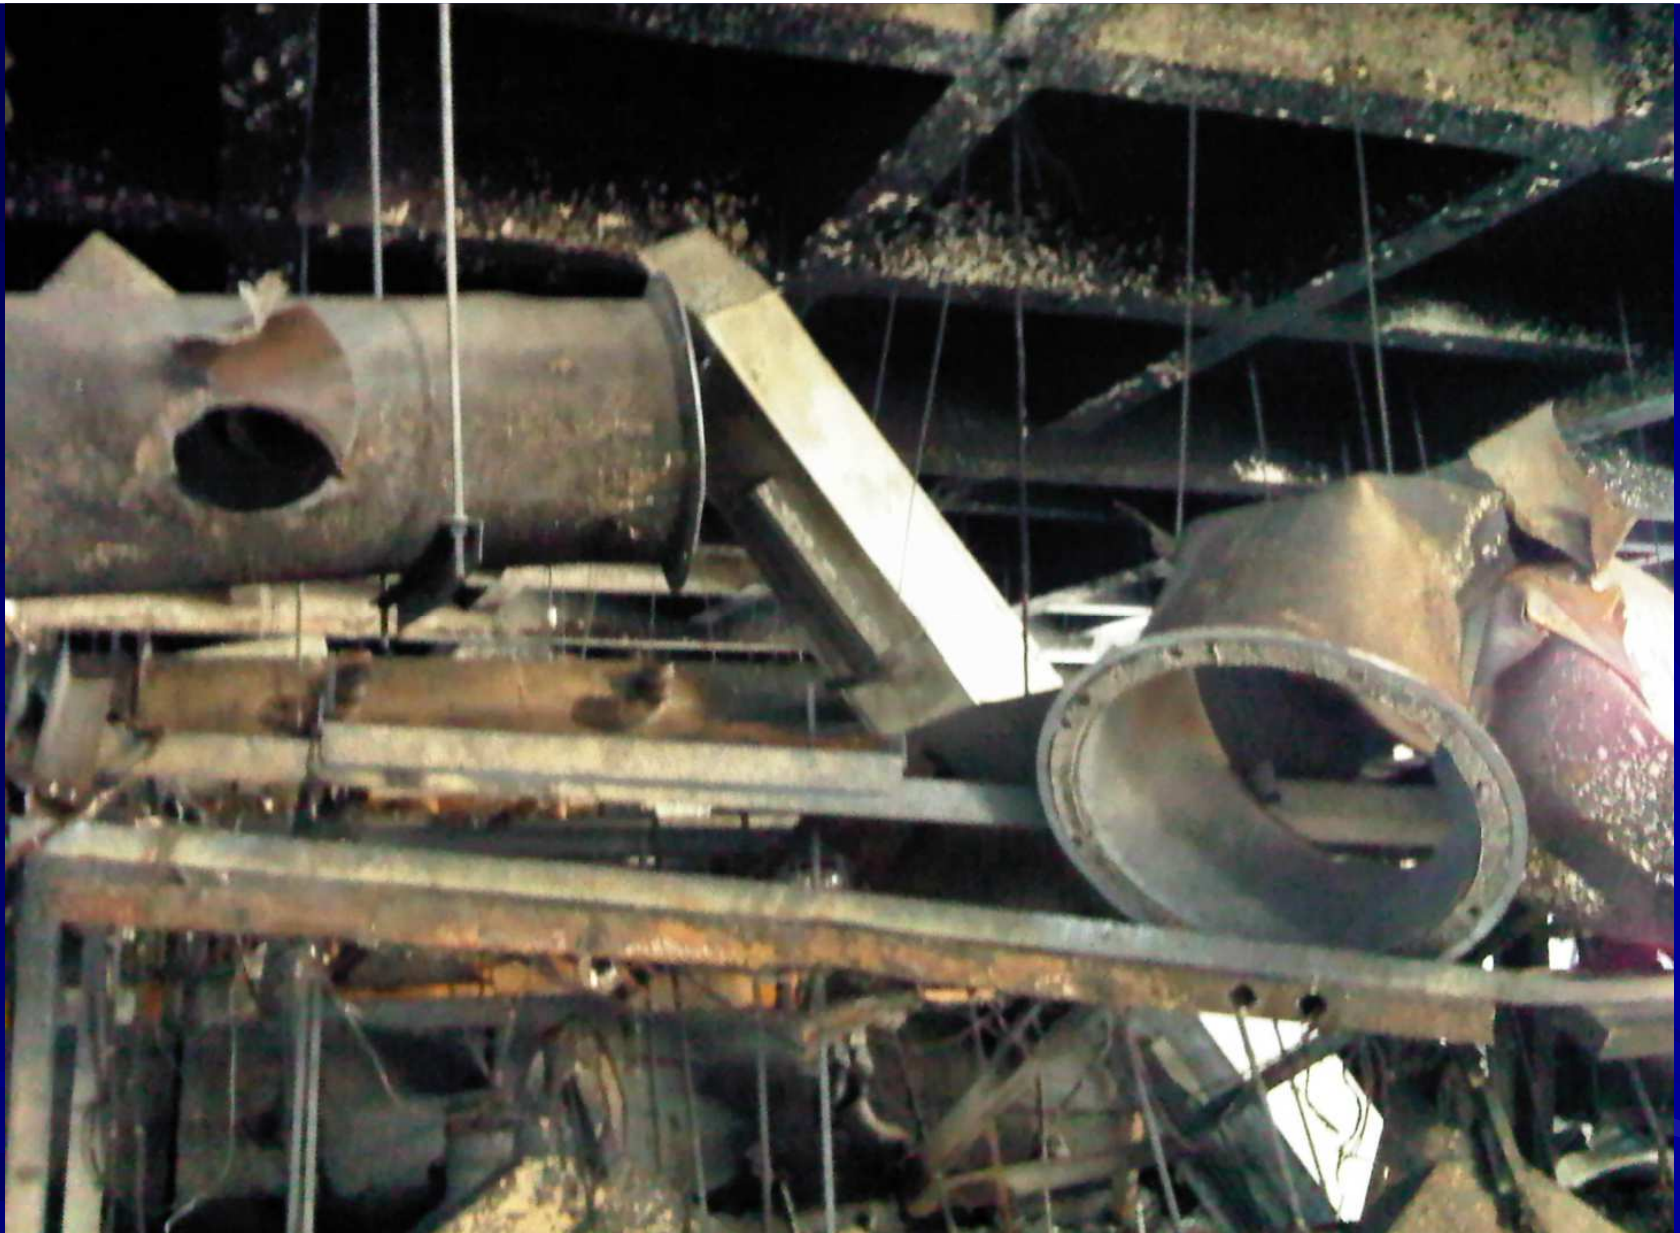
- The dust extraction ducts inside the building were basically intact, but the duct connected to the 1# filter suffered serious damage and got detached from the T-joint. A duct branch within the workshop was broke into three parts with the middle part of it having been torn apart. The dust filters (1#, 3#, 5# and 7#) collecting dust from the first floor were more severely damaged than those (2#, 4#, 6# and 8#) collecting dust from the second floor. In particular dust filter 1# was blown entirely apart.

- The dust extraction ducts inside the building were basically intact, but the duct connected to the 1# filter suffered serious damage and got detached from the T-joint. As *Figure 7-61* illustrates, the system of dust extraction ducts in the production halls was torn apart by the explosion.

**Figure 7-61. Detailed view of damage of dust extraction ducting.
From Li et al. (2016)**

- Therefore, good regular housekeeping to remove layers of accumulated waste dust is a most effective and practical way of preventing and mitigating serious secondary metal dust explosions in such plants. In addition, ignition source prevention, and explosion isolation between dust collecting systems and workrooms are important means for minimizing the risks of such explosions.
