# 'Bedenham' Accident 1

# 'Bedenham' Accident 2

- 1950 – Bedenham Pier:
  - Sabotage - thermite bombs! claimed as possible cause in the official media;
  - Even Board of Enquiry concluded fire was started by an incendiary device inserted into primer tube of a DC prior to loading into the NAL;
  - Claimed that the nature of the ammunition loading operation was widely known, and 8 possible locations for sabotage activity could be identified.
- 1951 – NAV Bedenham:
  - Following 2nd explosion a more scientific CINO (Chief Inspector Naval Ordnance) investigation took place;
  - Concluded probable cause of both accidents, involving the same DC Mk 7, was as a result of an 'obscure defect in a DC which caused a fire and minor explosion in proximity with other ammunition causing sympathetic explosion of the contents of the Lighter';
  - Concluded - in both cases initiation was by 'inflammation and not explosion or detonation'.

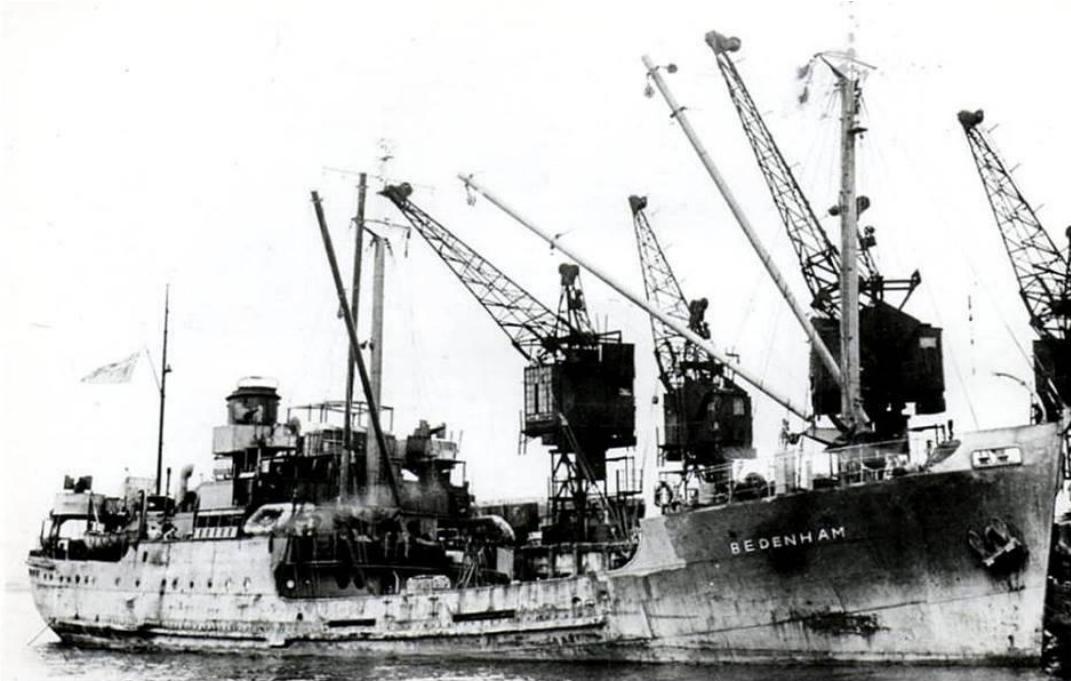
- Naval Armament Vessel (NAV) Bedenham:
  - Royal Fleet Auxiliary (RFA);
  - 1191tons;
  - Launched 1938, Troon;
  - 500tons of armaments (approx. 112tons NEQ).

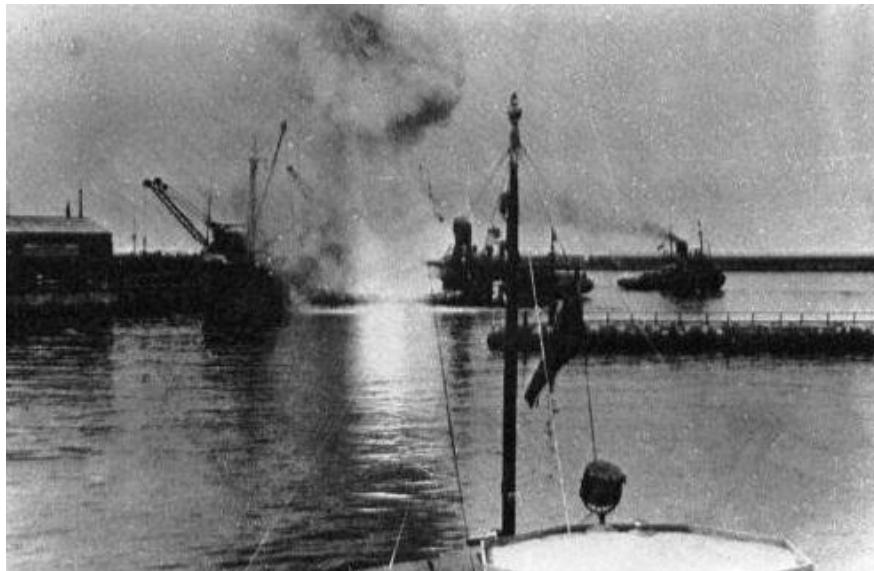
- What is Known:
  - 4 men in the barge, 2 handling & 2 sitting on the side nearest the ship;
- Localised Initial Explosion and Escalation:
  - Initial explosion killed 3 of the 4 workers in the barge;
  - Sole survivor jumped overboard, seriously burned, critically injured;
  - Initial explosion followed by major, escalating munitions fire;

- 6 minutes after the initial explosion a major cook-off occurred.
