Kjørbo Incident

HRS explosion 2019

**Hydrogen Safety:
Kjørbo-incident, overview and
perspectives**

CIENS, Oslo, October 23, 2019

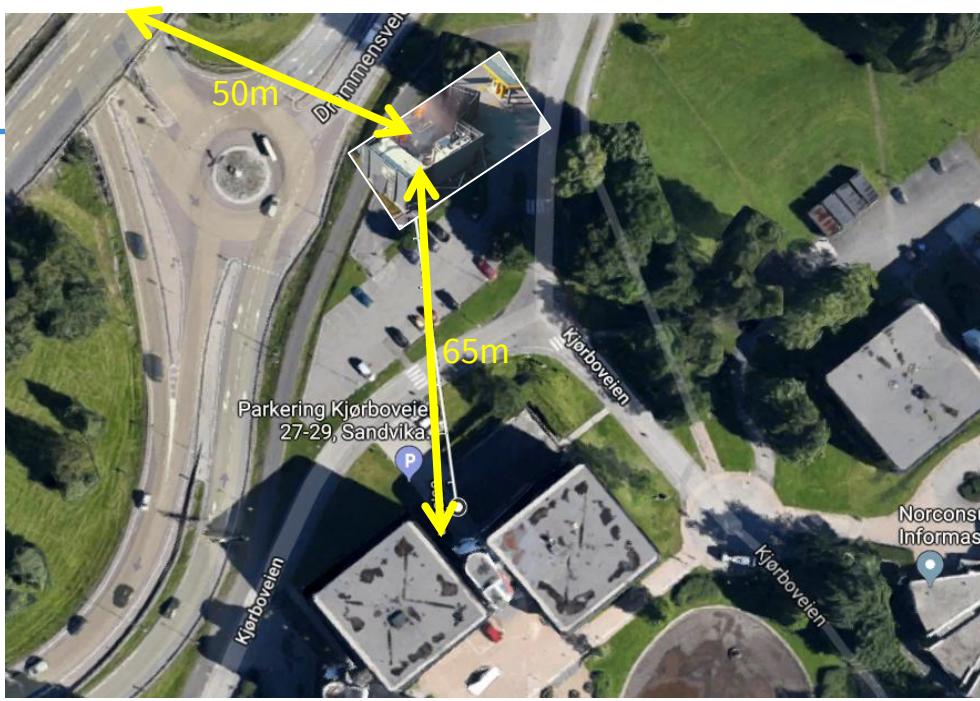
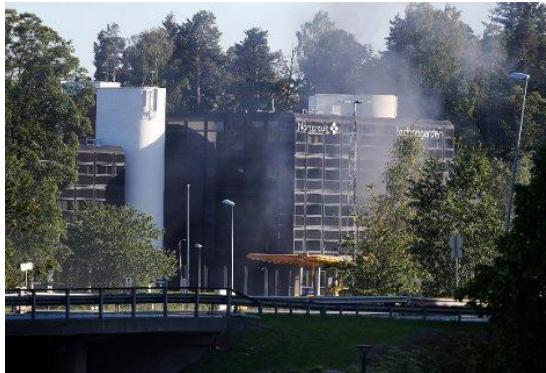
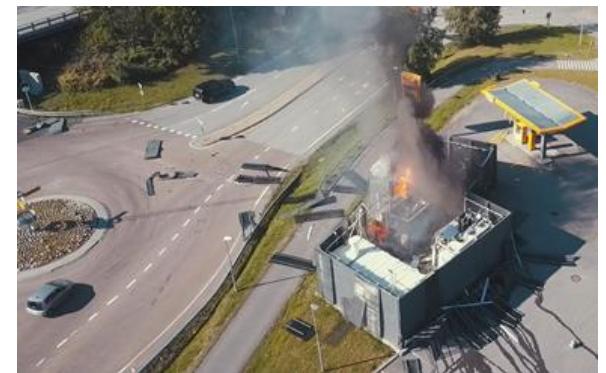
- Road and roundabout ~ 10m away
- Main highway (E18) 50m away (elevated)
- Office buildings ~65m away

The fence around the hydrogen units generally fulfilled its mission and protected the near surroundings from flames and direct explosion effects.

A limited part of the fence towards the roundabout however failed, generating potentially dangerous projectiles.

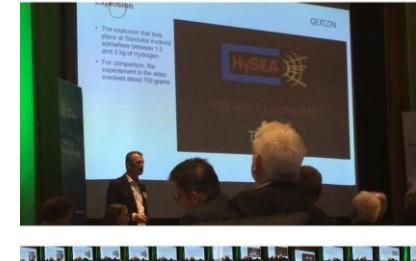
- Small leak for a couple of hours (0.04 g/s ?) from 950 bar tank
- Sudden failure of seals => 1.5-3.0 kg released in 3 seconds (Gexcon Florø presentation)
- Strong explosion (followed by second explosion inside compressor module?)
- “Maybe local DDT in compressor module” (Gexcon response to my question in Florø whether DDT was considered)

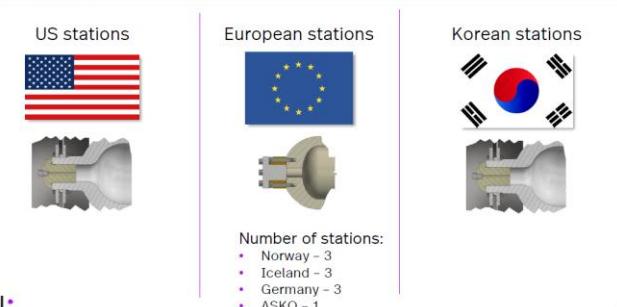
Plug design, unique to Europe
Certified by third parties

- To reduce channel diameter (22mm) significantly to limit leak rate potential
- To avoid dependency on tightening of bolts and seals that may deteriorate

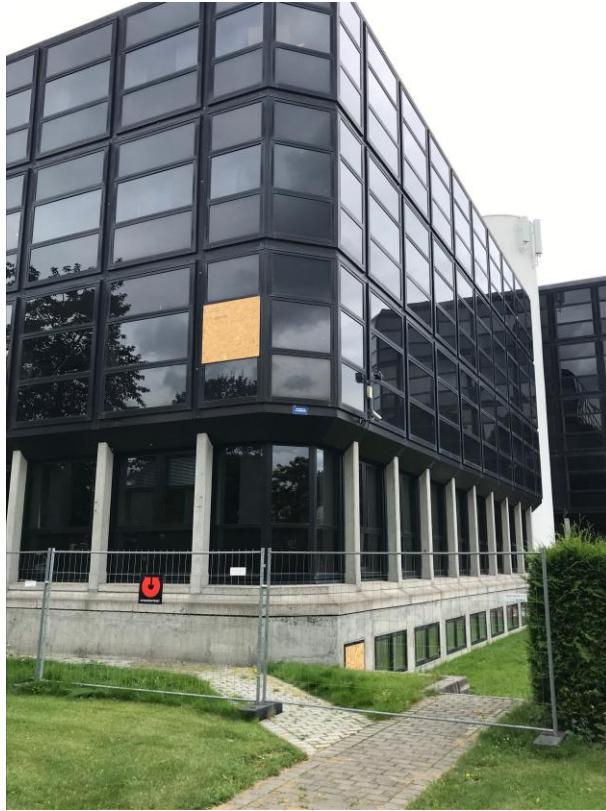
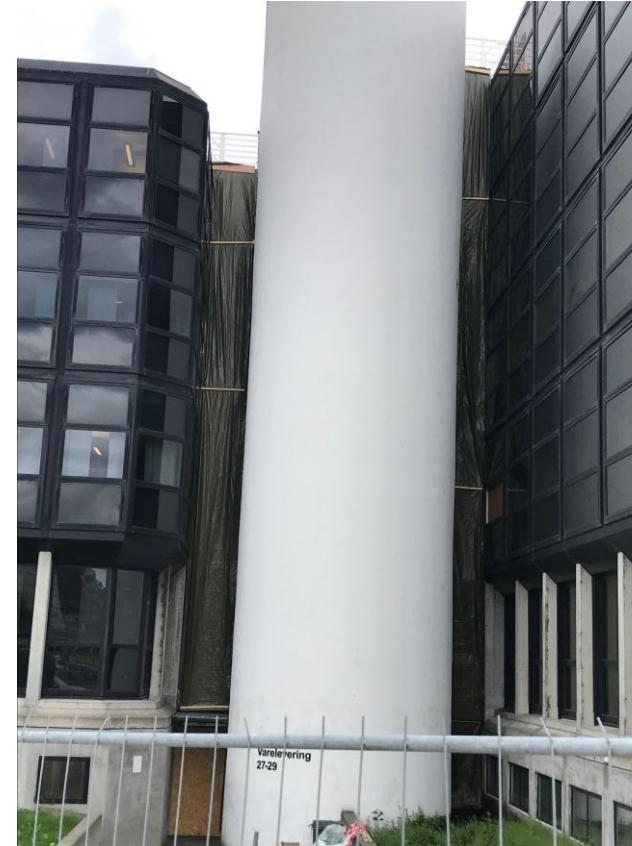
Visible building damage (6 weeks after explosion)

A few scattered windows, indication of more severe impact in corner

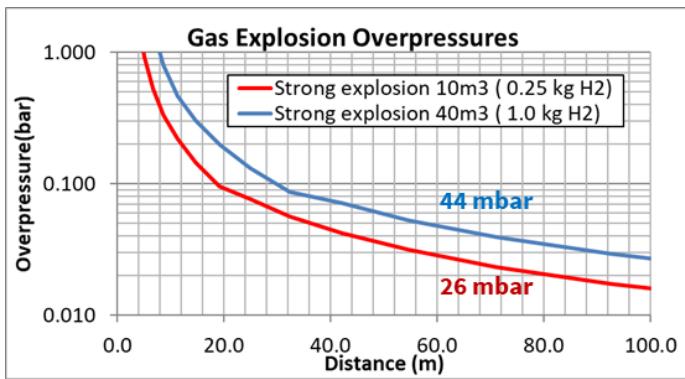
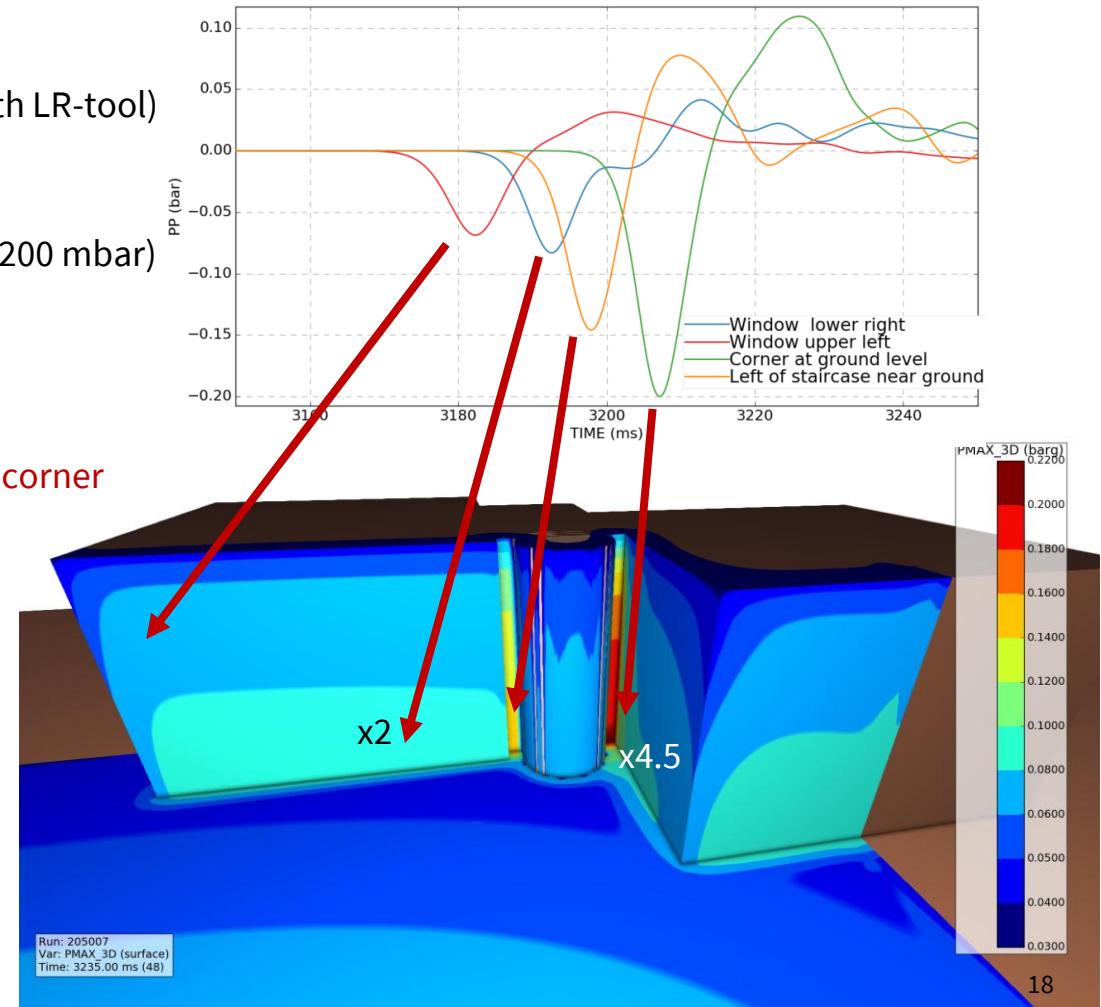
Blast onto building

- Side-on pressure ground level ~45 mbar (consistent with LR-tool)
- Reflection x2 at front of building (90 mbar)
- Focused/reflected pressure 4-5 times higher in corner (200 mbar)

Due to shape of building, high pressures to be expected in corner

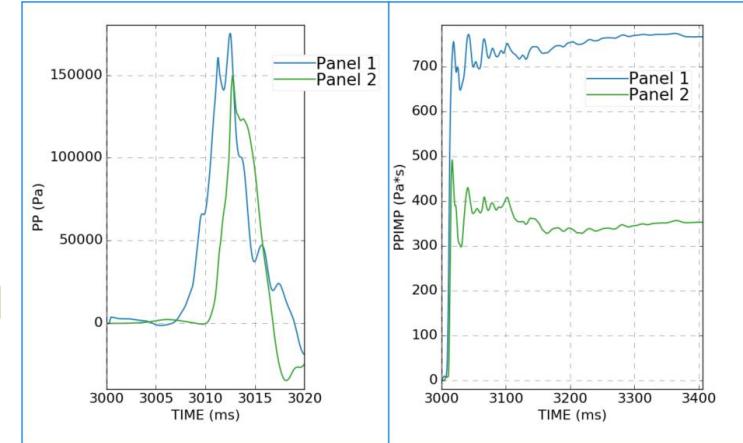
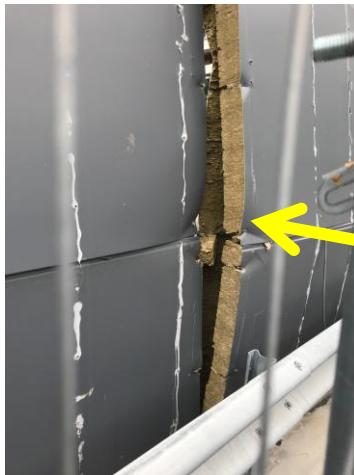
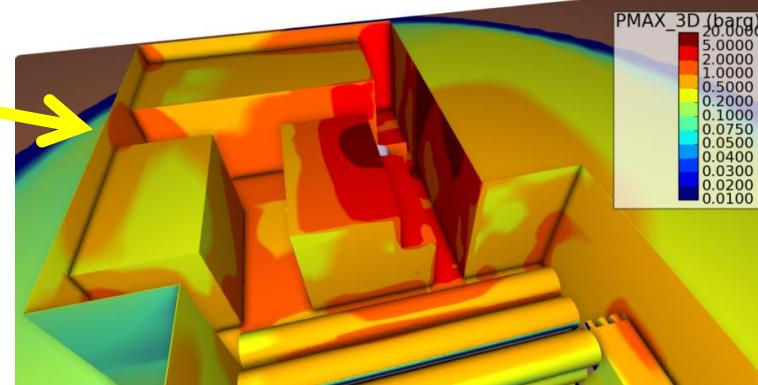
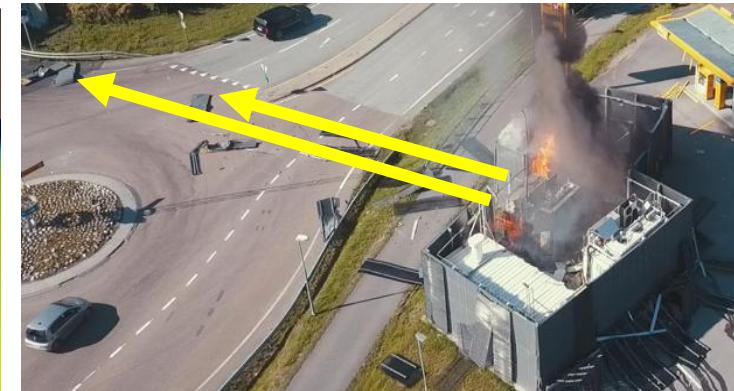
Wall projectiles

- Local pressure 10+ bar, average (2m x 3m panel) 1.5-1.8 bar
- Impulse 750 Pa s and 500 Pa s
- Weight of wall elements unknown
- 750 Pa s may throw 75 kg wall element ($2m^2$) 41m

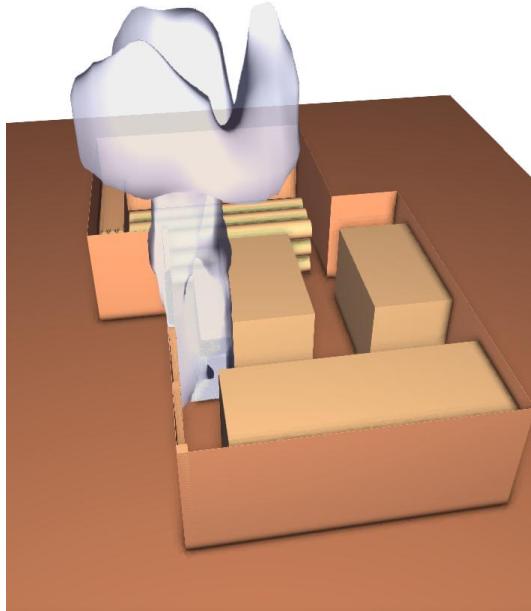
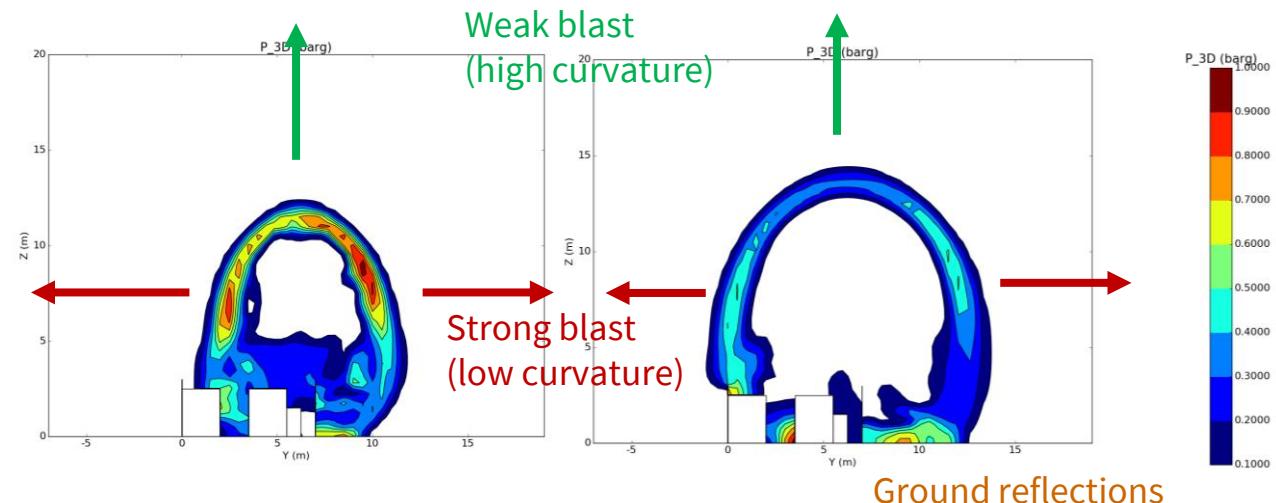
Blast exposure onto highway (E18)

Vertical elongated cloud may explain significant blast onto nearby elevated road

- Direct line of sight
- Shape of cloud would enhance horizontal blast strength

Prediction is supported by detonation experiments of elongated gas clouds giving double blast pressures across axis vs along

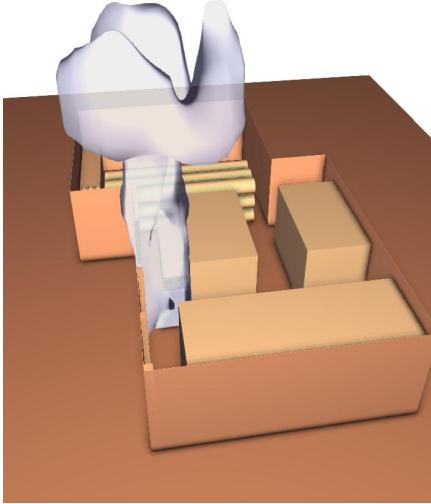
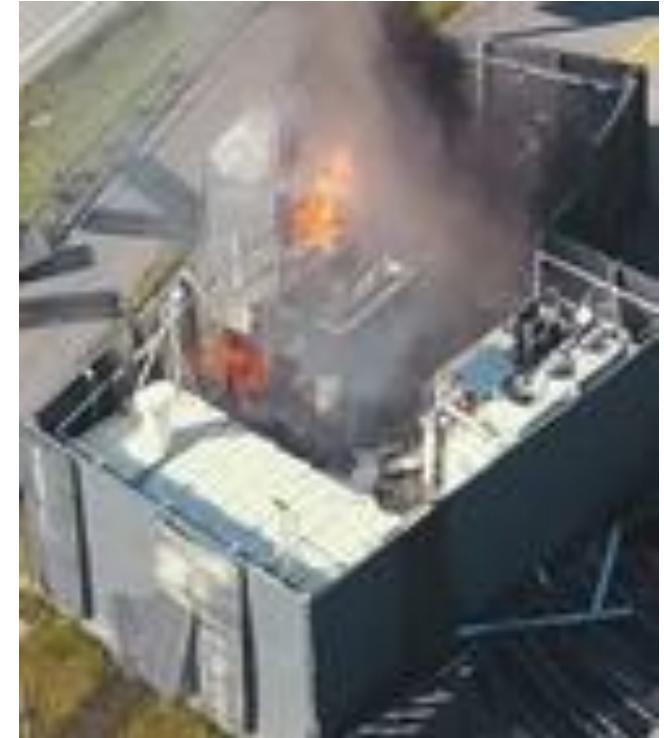
Second explosion in compressor module?

Gexcon mentioned “possible local DDT inside compressor module” & witness reported 1 strong +3 weak explosions

- Very strong outdoor explosion may have shaken compressor module and led to leak inside (?)
- With leak inside, and fires outside, ignition and explosion no surprise
- Pressure likely vented through doors and vent in roof
- Limited cloud volume (worst-case ~10m³), fences would mitigate blast outside
- I doubt this scenario can explain failing fence or strong blast onto road/offices
