UKELG at 50 – Cardiff – July 2013

**Explosions caused by
contaminated nitric acid –
two case studies**

Ivan Vince

ASK Consultants

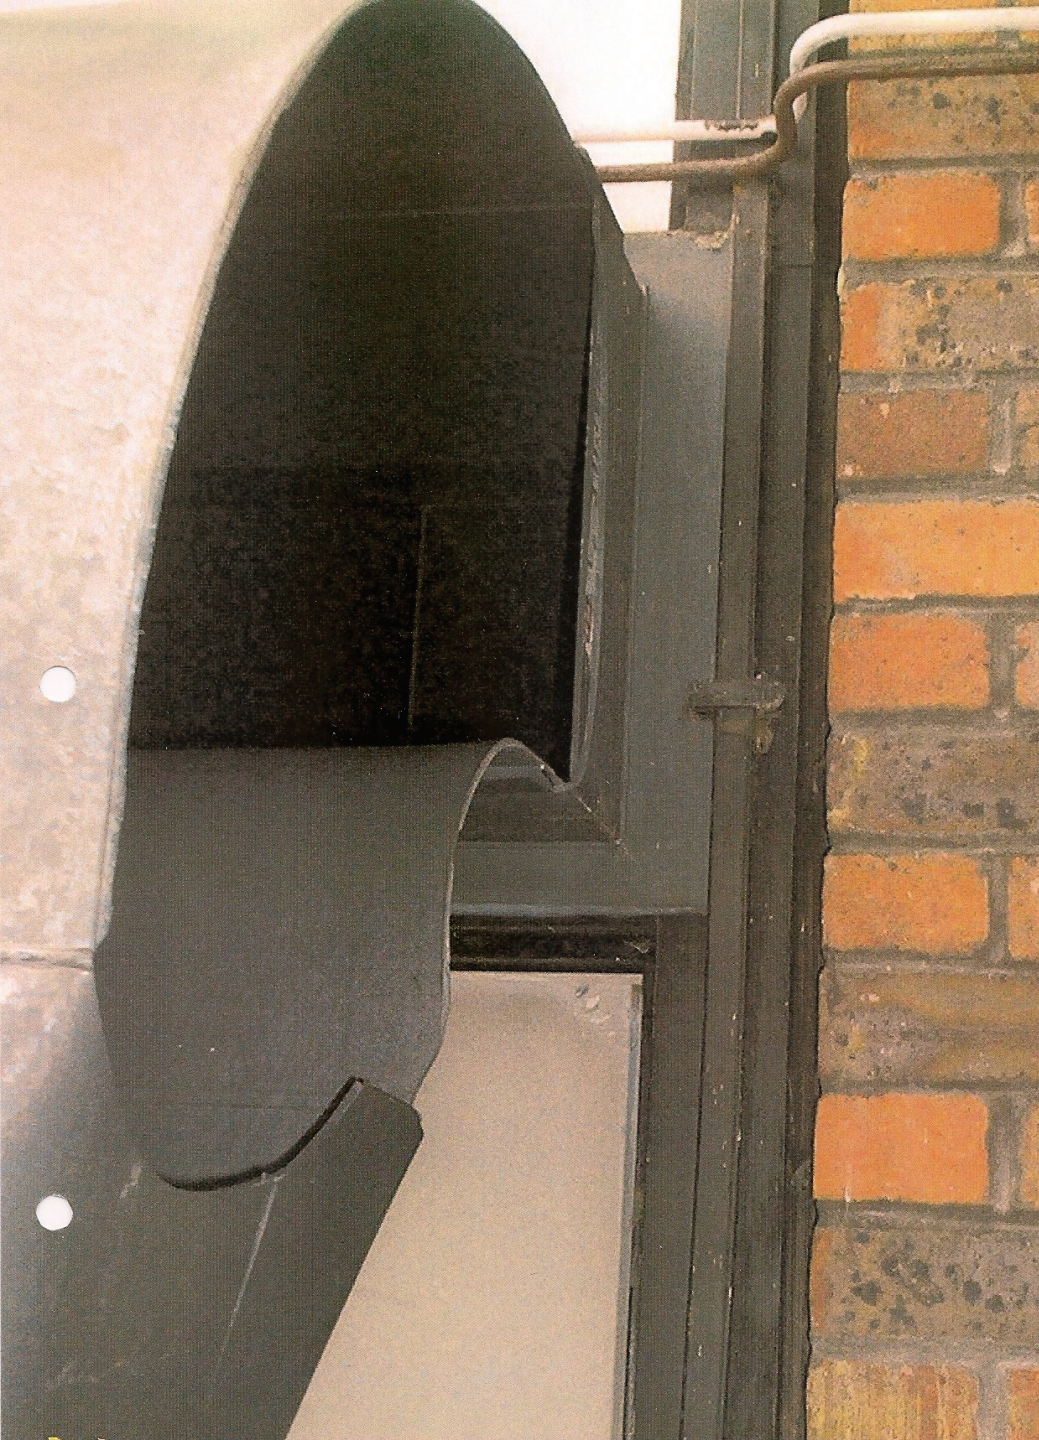
**Ruptured
extraction
ducting**

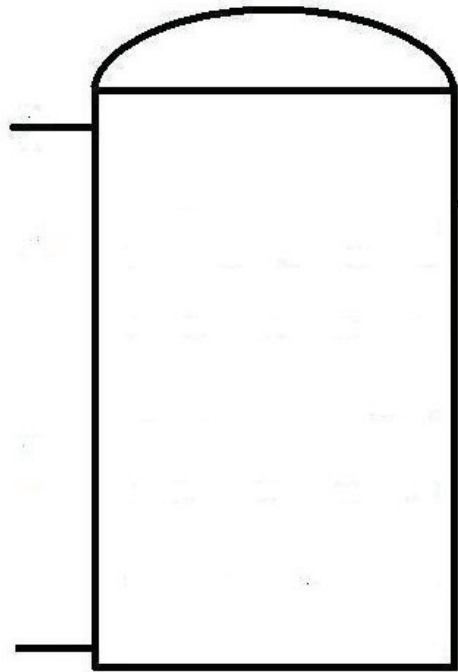
Nitric acid

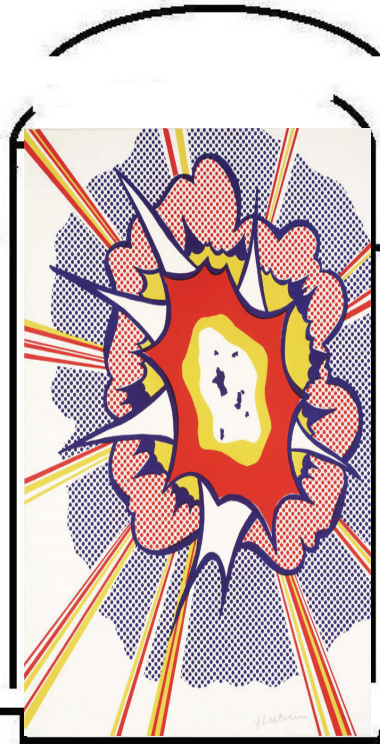
Knock-out

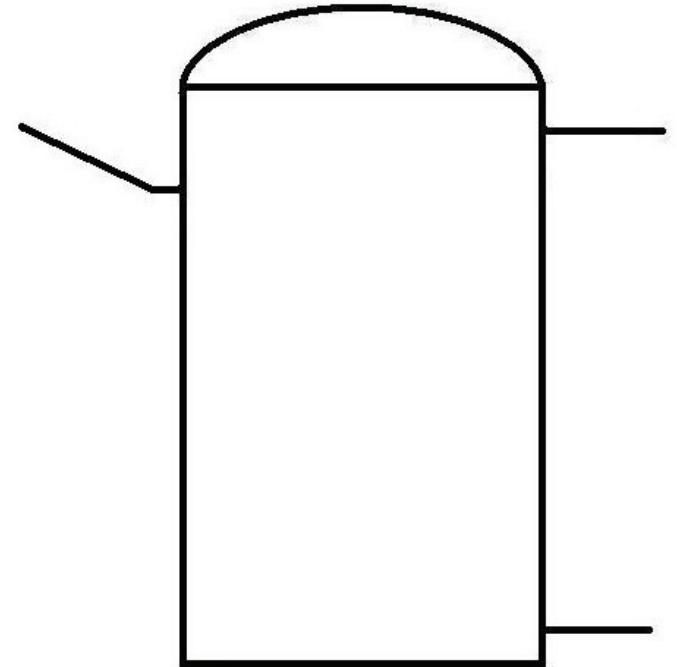
**Caustic (aq)
+ organics**

Acid + metal \rightarrow hydrogen ?

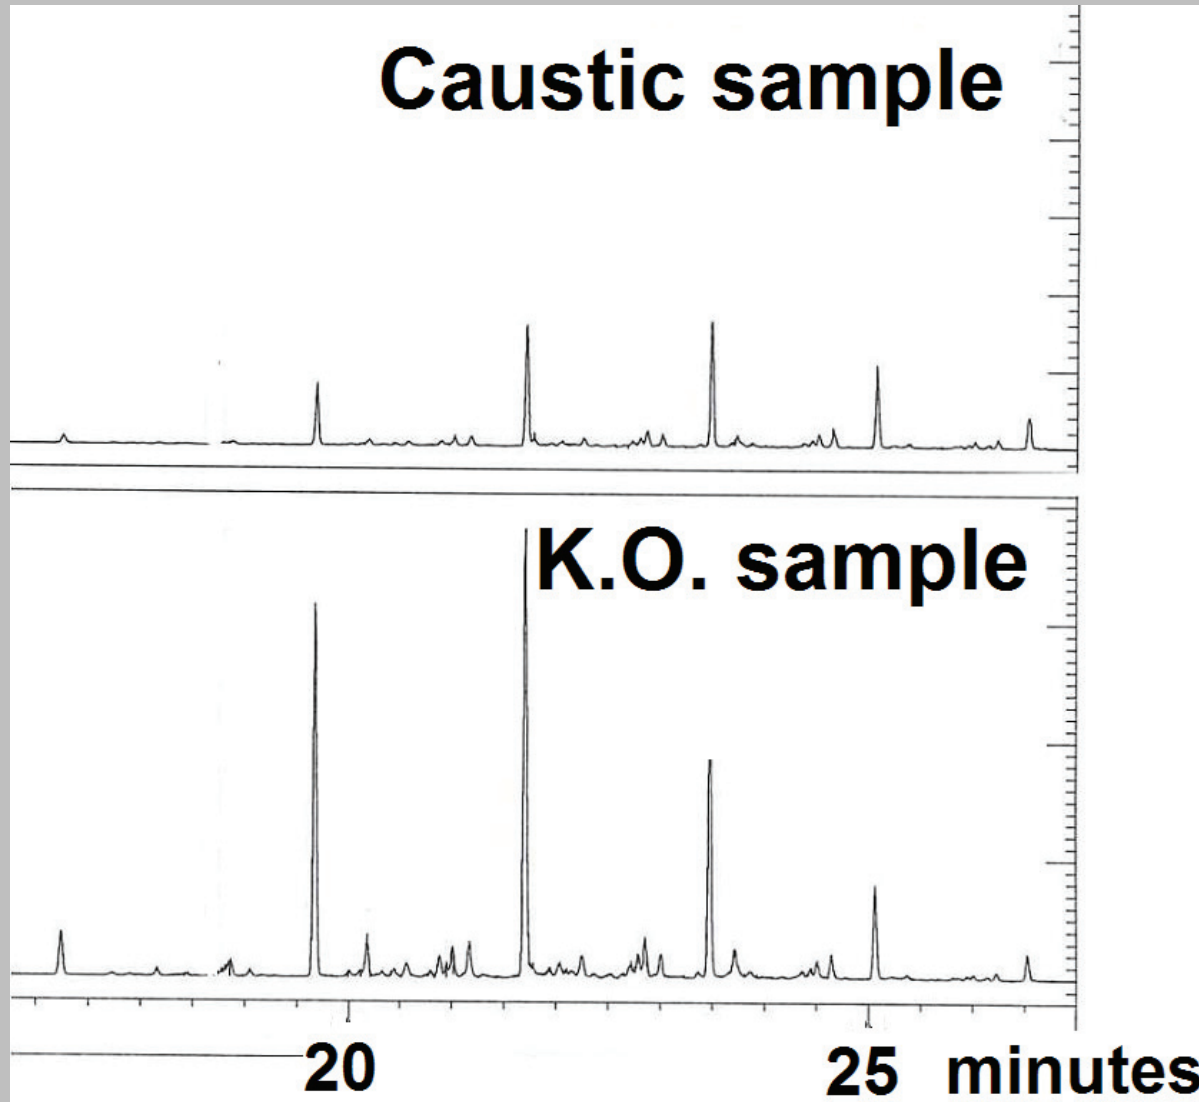
K.O. sample pH ~11

Head space analysis by GC

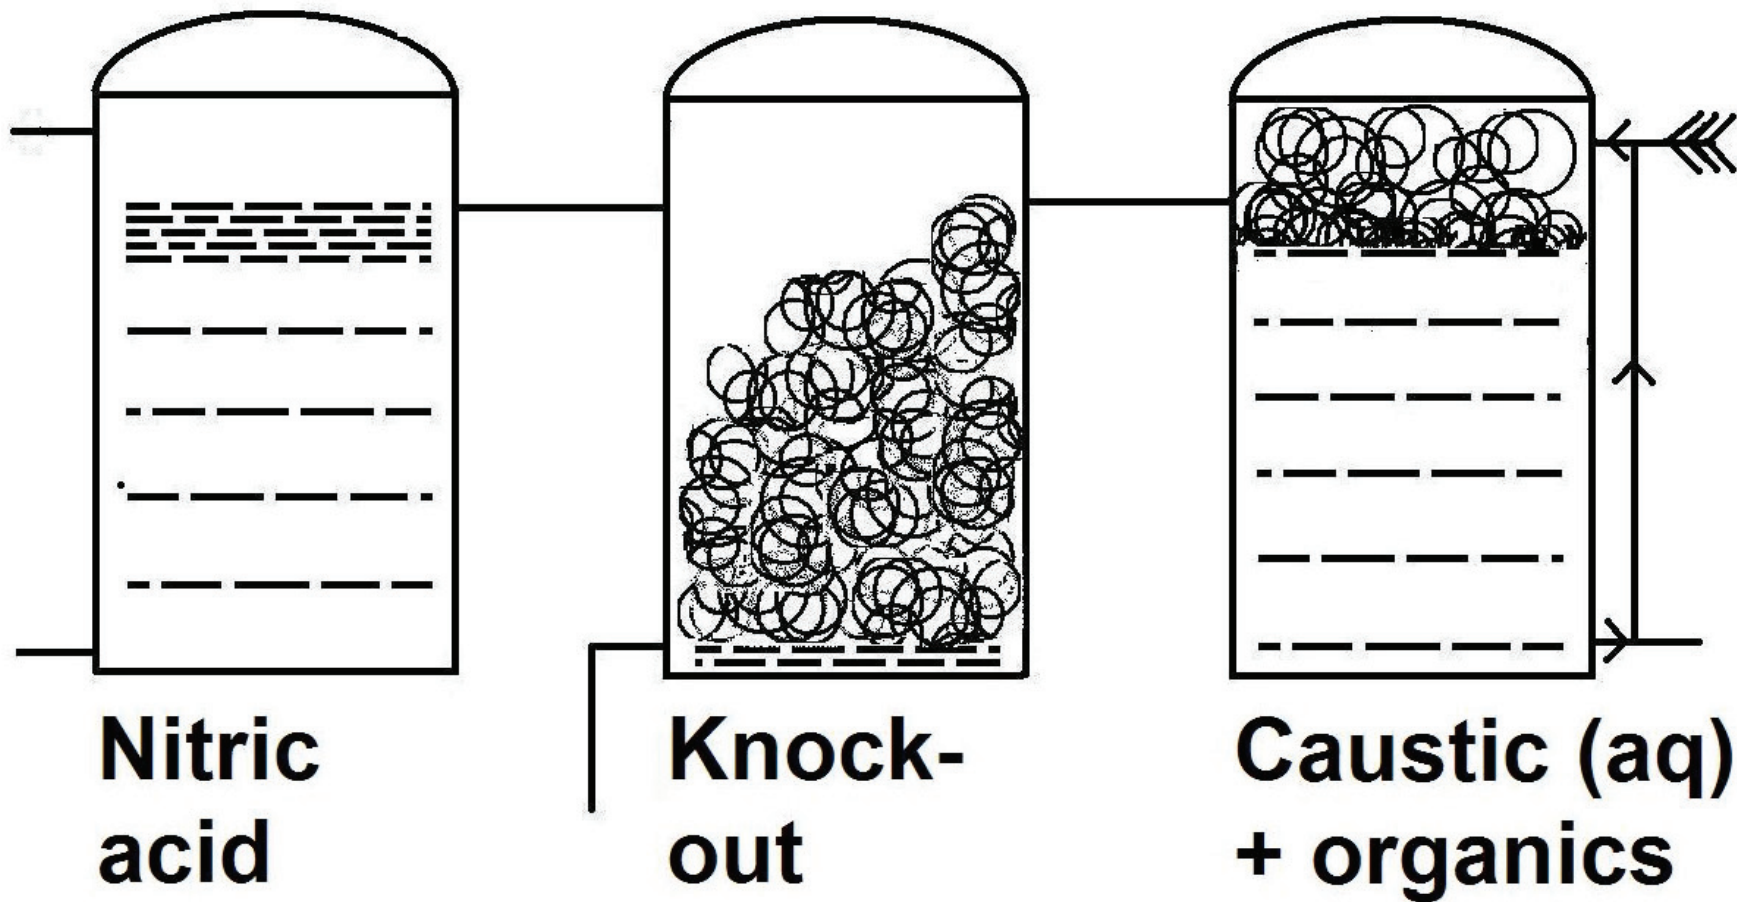
**Trace nitroaromatic detected
in K.O. sample**
