# 'Bedenham' Accident 1

# 'Bedenham' Accident 2

- 1950 – Bedenham Pier:
  - Sabotage - thermite bombs! claimed as possible cause in the official media;
  - Even Board of Enquiry concluded fire was started by an incendiary device inserted into primer tube of a DC prior to loading into the NAL;
  - Claimed that the nature of the ammunition loading operation was widely known, and 8 possible locations for sabotage activity could be identified.
- 1951 – NAV Bedenham:
  - Following 2nd explosion a more scientific CINO (Chief Inspector Naval Ordnance) investigation took place;
  - Concluded probable cause of both accidents, involving the same DC Mk 7, was as a result of an 'obscure defect in a DC which caused a fire and minor explosion in proximity with other ammunition causing sympathetic explosion of the contents of the Lighter';
  - Concluded - in both cases initiation was by 'inflammation and not explosion or detonation'.

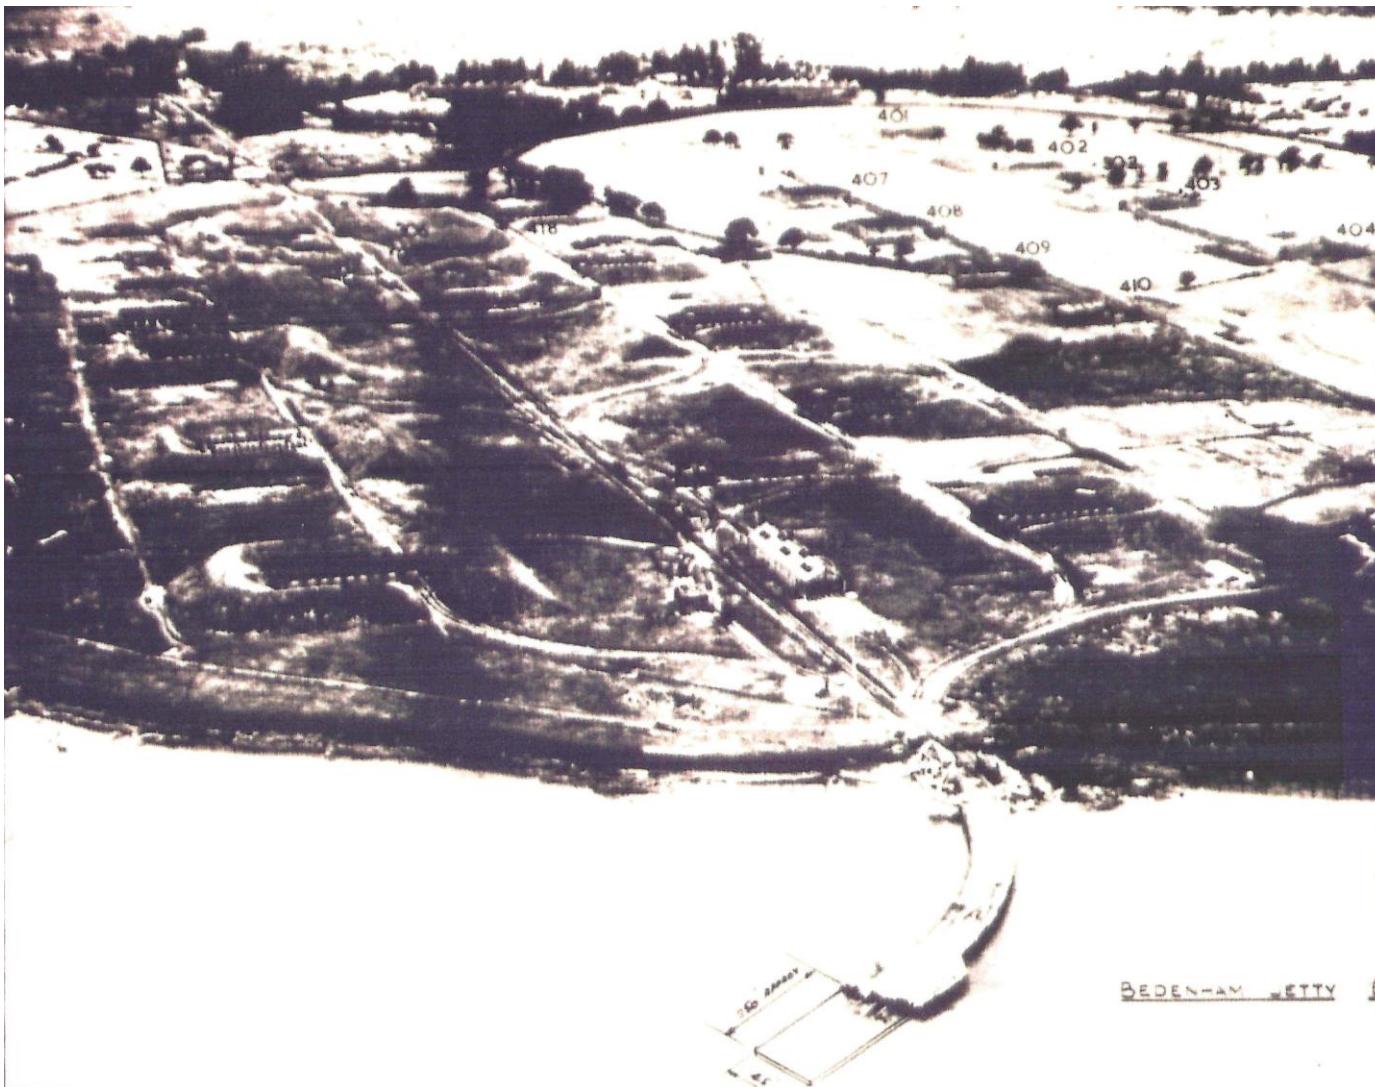
- Detonation:
  - 18:47 - First mass explosion;
  - Demolished the centre portion of the pier, ~40 yard breach;
  - Extensive blast damage caused to many of the buildings in the depot;
  - 2 cranes on the pier had disappeared and 1 NAL sunk.
  - 19:15 - Second mass explosion;
  - Smaller than the first but projected debris was more intense;
  - Starting more small fires in the depot;
  - Most depot staff engaged in fighting small fires in order to protect magazines;
  - Hampered by large number of scattered unexploded Bombs and Shells;
  - 21:00 - Main fires had been extinguished;
  - Civilian fire assistance was withdrawn by 09:00 the following morning.

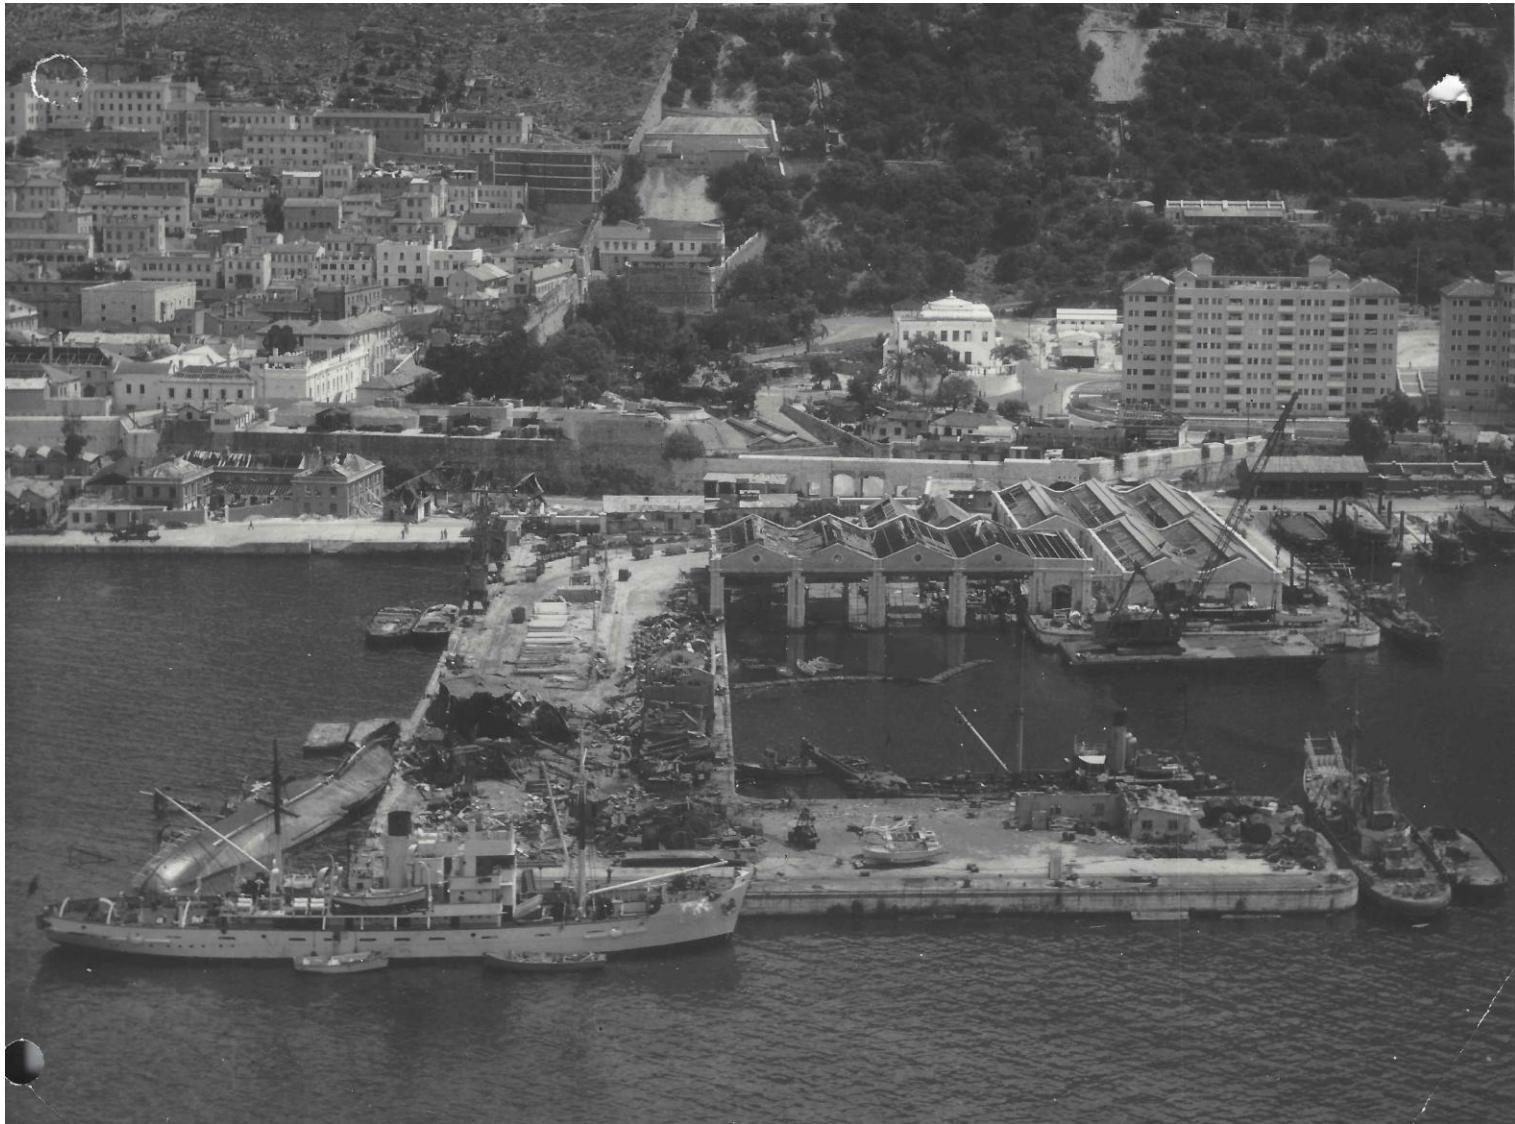
- Consequences:
  - Ship’s crew and many workers safely evacuated/took cover;
  - Scattered debris over wide area;
  - NAV Bedenham was split into two parts;
  - 13 killed, ~200 civilian patients treated for cuts and abrasions;
  - ~500 properties damaged by blast;
  - Two cranes, several vehicles and dockside buildings destroyed;
  - Bofors ammunition (cargo from NAV Bedenham) was scattered onto Wharf and around Naval base;
  - 90% of ammunition in the Depot rendered un-servicable.
- George Cross:
  - Sub-Fire Officer George Campbell Henderson was posthumously awarded the George Cross for staying and attempting to fight the fire. He remained on the NAV Bedenham with a hose trained onto the NAL and was killed when the ammunition detonated.

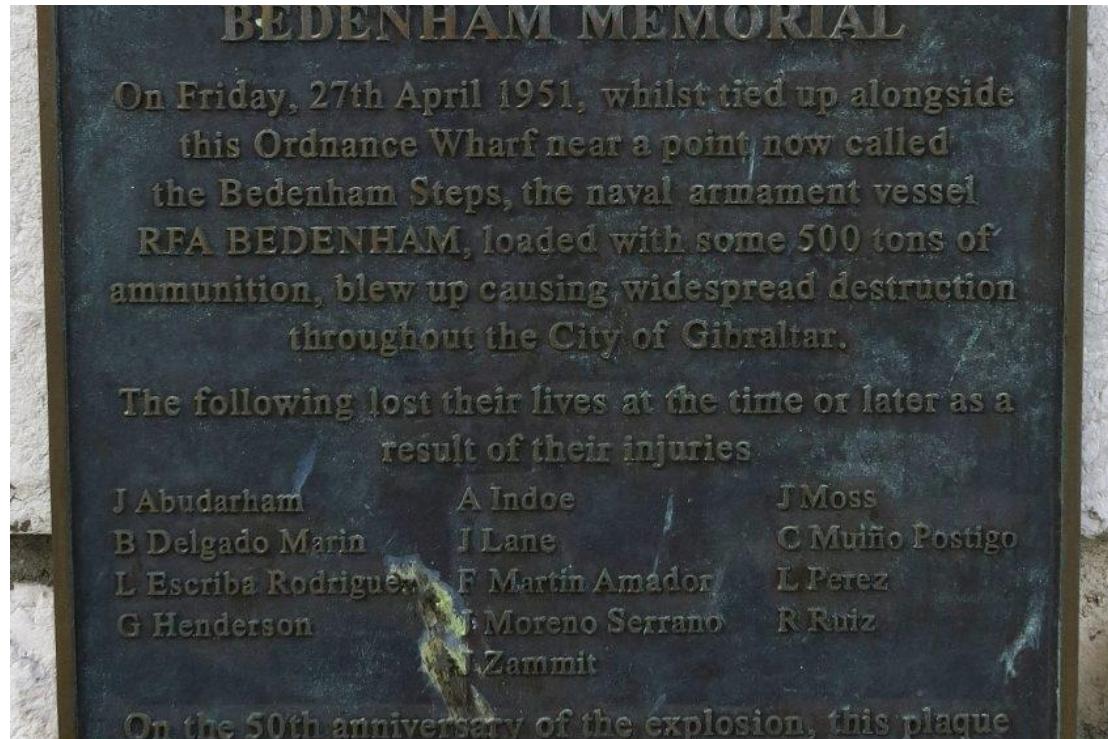
In Memory of those killed in Gibraltar, April 1951:
