Kjørbo Incident

HRS explosion 2019

**Hydrogen Safety:
Kjørbo-incident, overview and
perspectives**

CIENS, Oslo, October 23, 2019

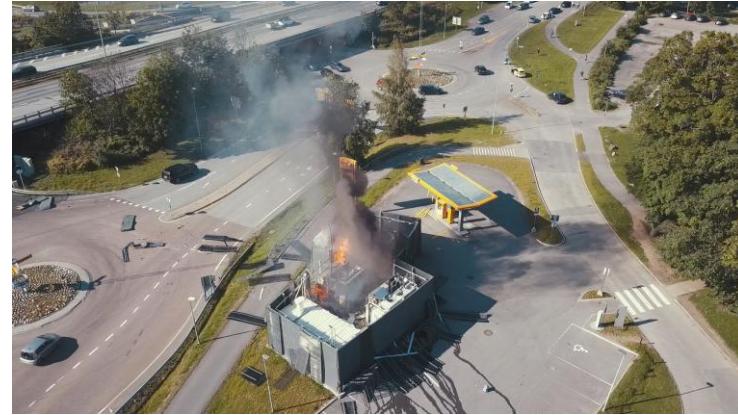
Newspapers reported/claimed various things:

- Two people checked at emergency room **after air-bags activated**
- Some newspapers reported “tank rupture”
- Dog jumped from 4th floor, window damage at office buildings
- One witness told about **1 strong and 3 weaker explosions**

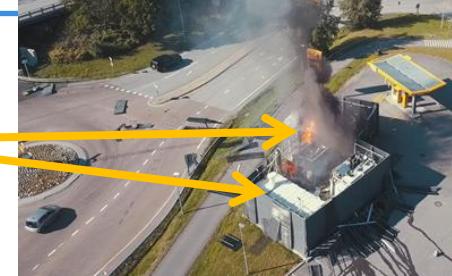
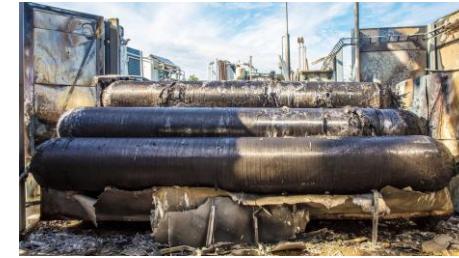
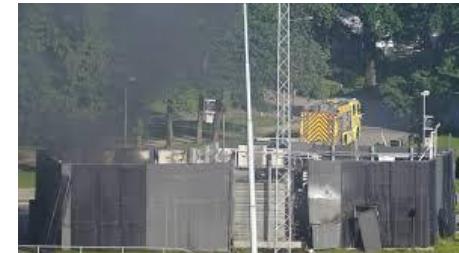
Main candidates to the blast breaking windows at 65m distance:

- Compressor module (on fire) or electrolyser module (seemed unaffected)
- Outdoors explosion between compressor module and fence?
- Rupture of large composite tanks?

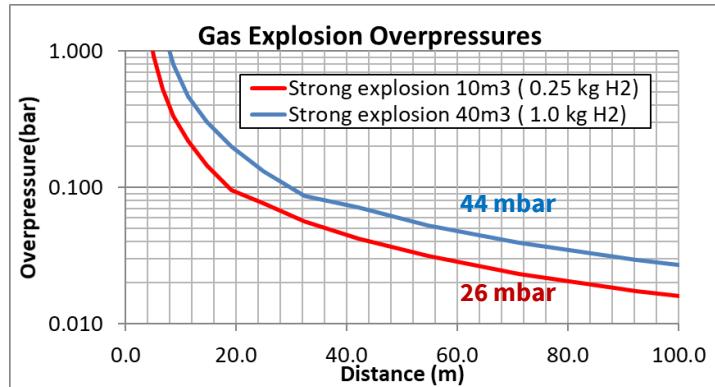
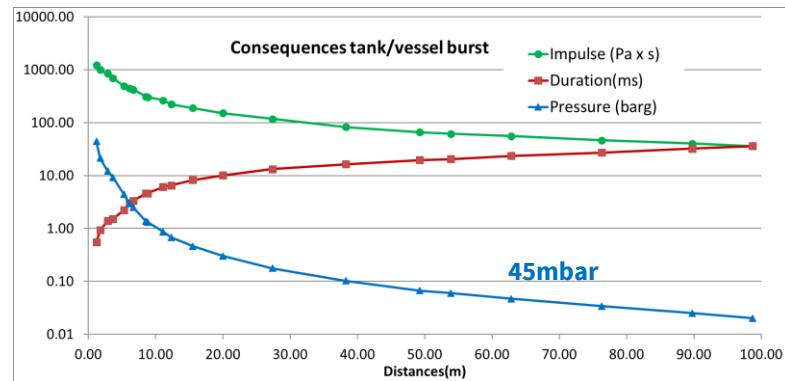
Prediction by LR consequence screening tool – used for risk assessments

Hard to explain fence failure by module explosion, storage tank rupture soon reported not to be source of blast

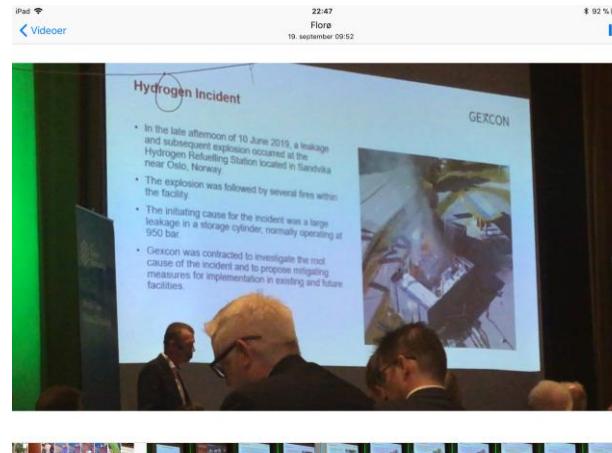
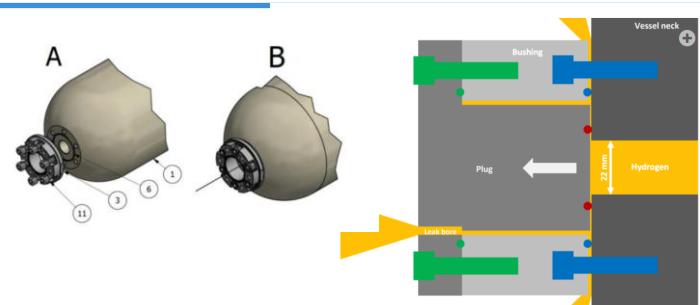
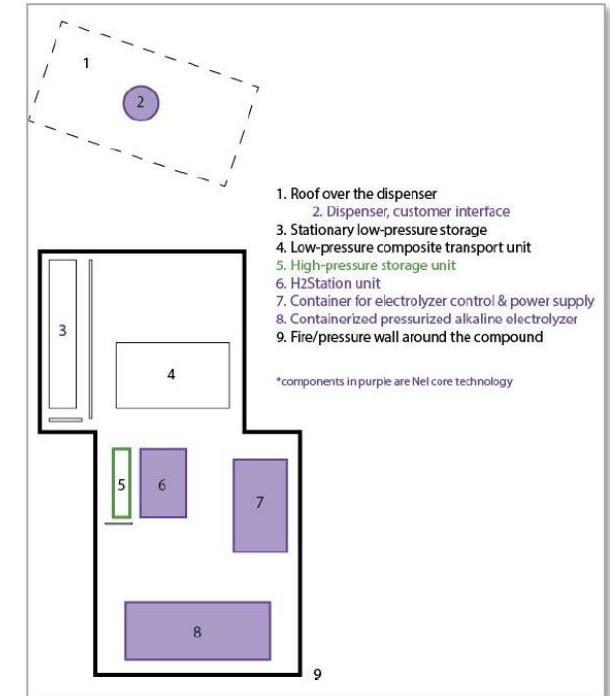
Gexcon incident investigation for NEL

- Small leak for a couple of hours (0.04 g/s ?) from 950 bar tank
- Sudden failure of seals => 1.5-3.0 kg released in 3 seconds (Gexcon Florø presentation)
- Strong explosion (followed by second explosion inside compressor module?)
- “Maybe local DDT in compressor module” (Gexcon response to my question in Florø whether DDT was considered)

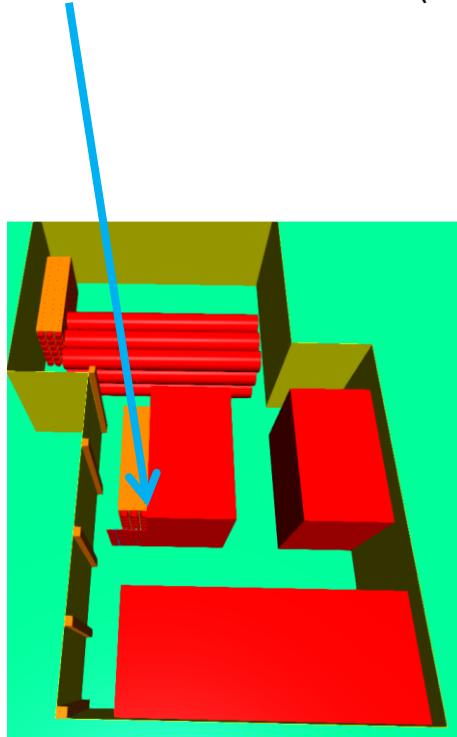
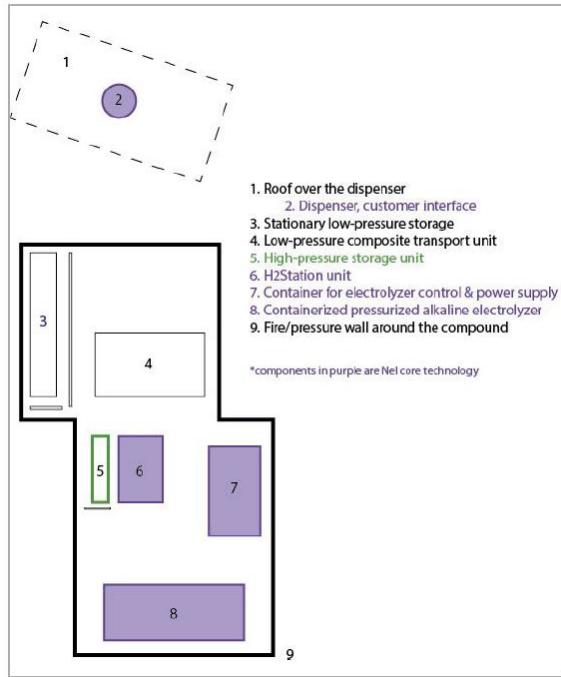
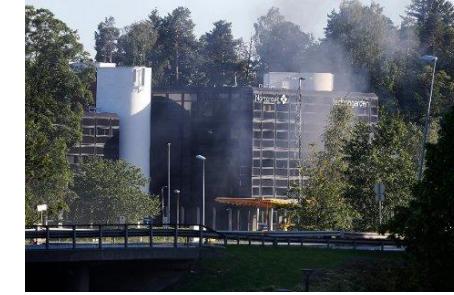
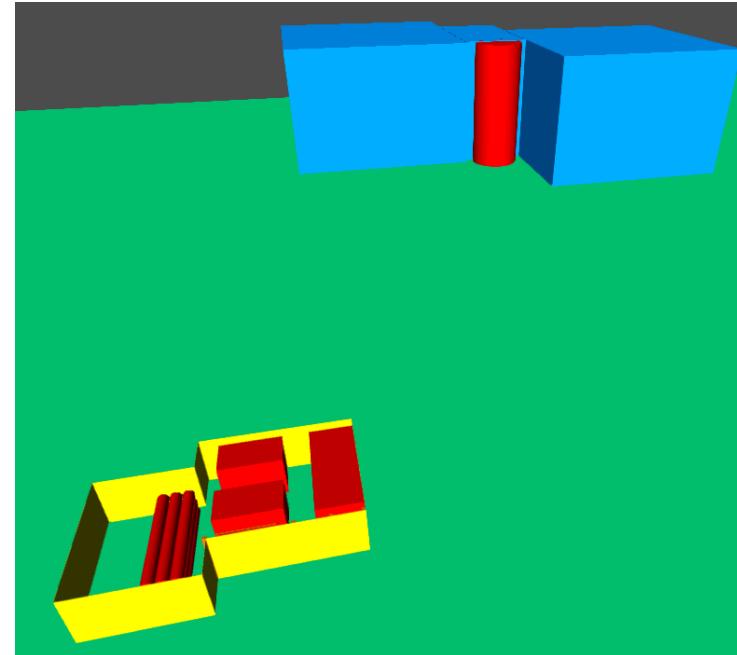
3D model for CFD-simulations

Simplified 3D model based on sketch from NEL and photos from accident

Fences are more rectangular than in reality, exact dimensions not known

Assumed leak location (at ground level)

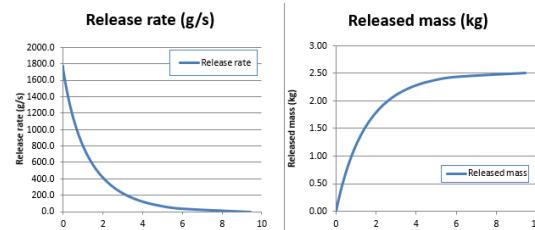
Release profile 7mm hole (38.5mm²)

- 1650 g/s to 237 g/s in 3s
- 2.0 kg released

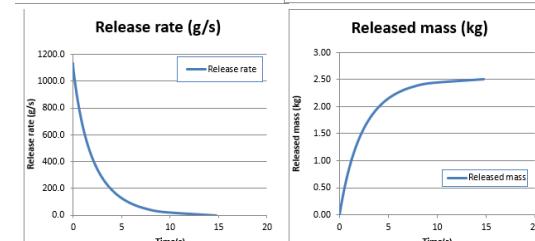
Release profile 5.5mm hole (23.7mm²)

- 1000 g/s to 285 g/s in 3s
- 1.7 kg released

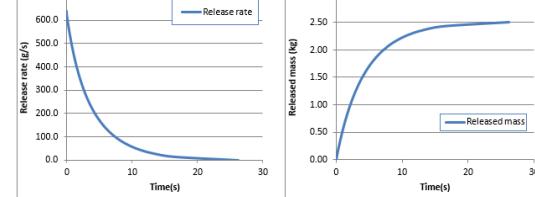
Release profile 4.4mm hole (15.2mm²)

- 640 g/s to 275 g/s in 3s
- 1.3 kg released

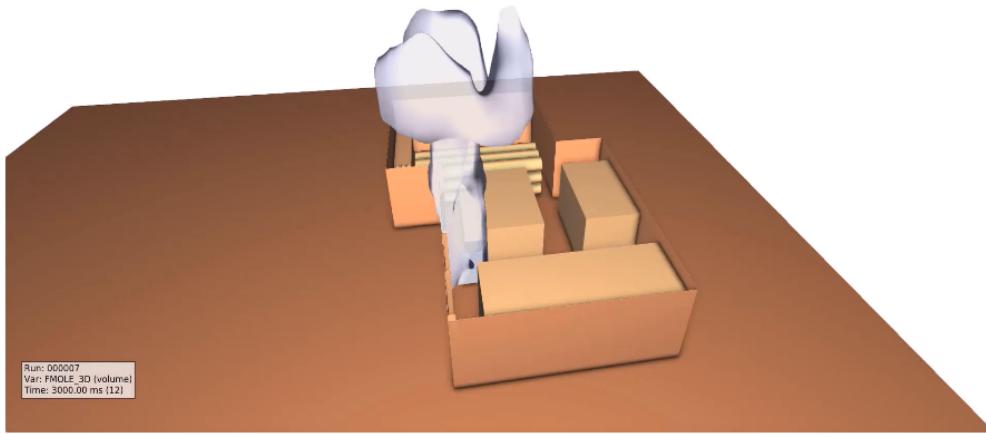
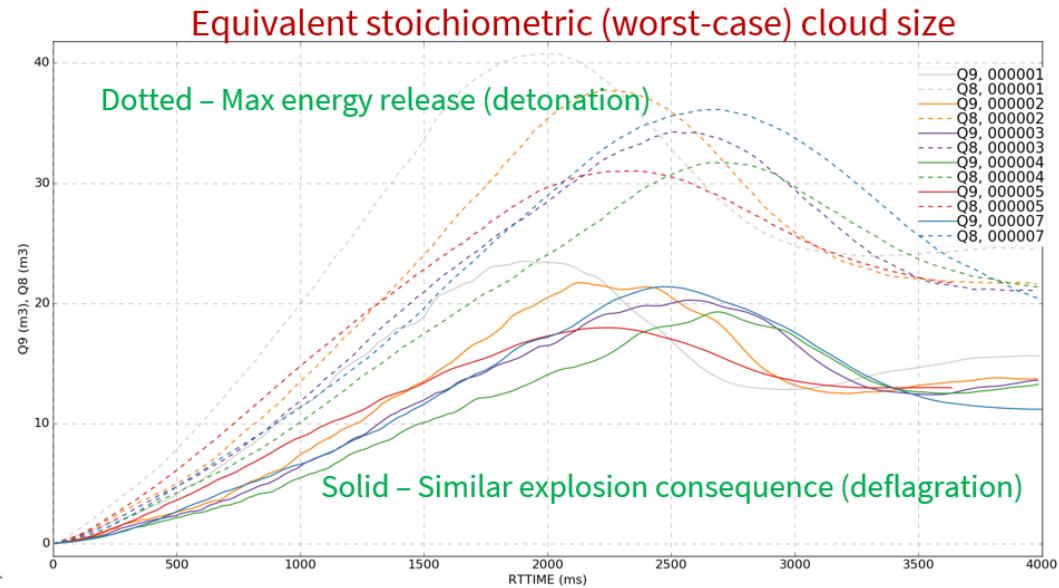
Equivalent stoichiometric cloud (Q9) was predicted to 13-18m³ (0.33-0.45 kg hydrogen)

640 g/s initial rate used (worst case at 3s)
Reactive plume 15-60% shown

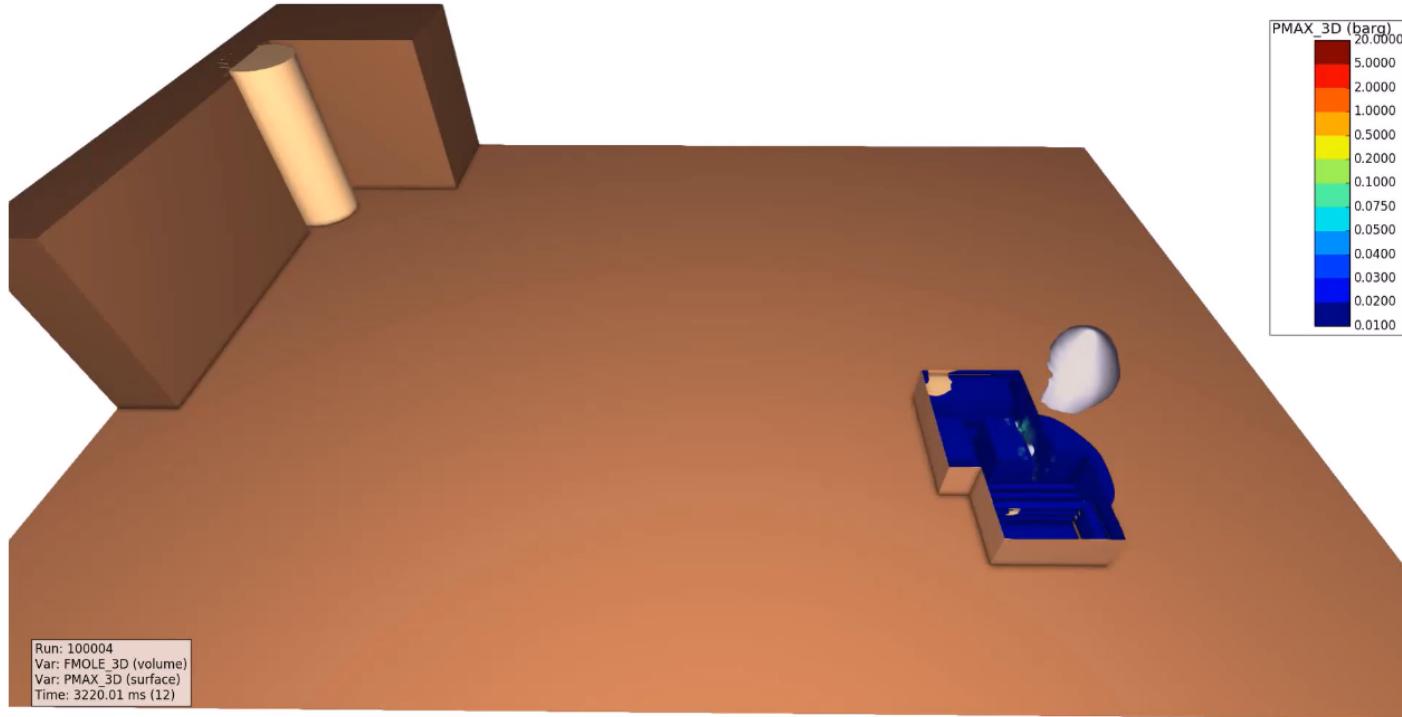
What if we explode the cloud with FLACS?

640 g/s initial release rate exploded (most reactive gas cloud at 3s, 0.45-0.85 kg hydrogen)

Can observed damage be explained by deflagration?

Slow explosion (~300-500ms)

- Strong deflagration requires very reactive gas cloud and high turbulence
- Questionable if unconfined part of cloud will burn fast to generate pressures

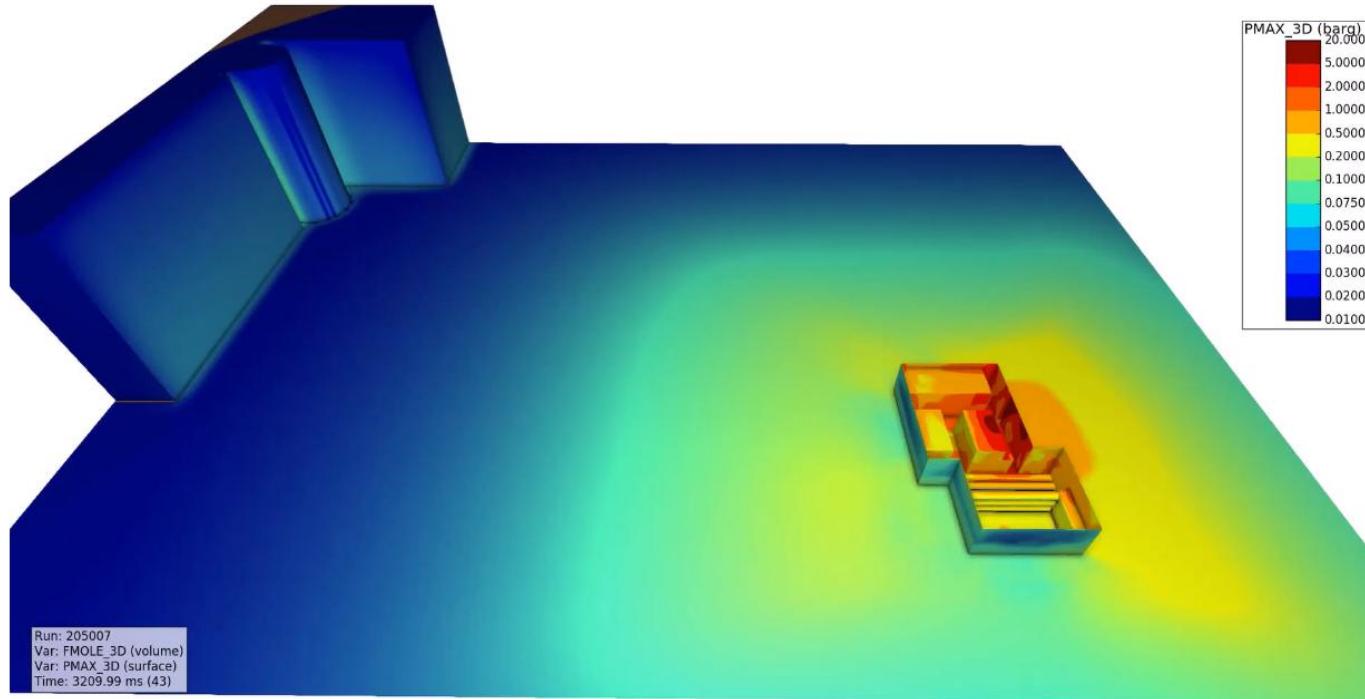
What if we detonate the cloud with FLACs?

640 g/s initial release rate exploded (most reactive gas cloud at 3s, 0.45-0.85 kg hydrogen)

PS! Simulation is based inaccurate description of event and on worst-case dispersion scenario evaluated.
Actual blast waves may be weaker.

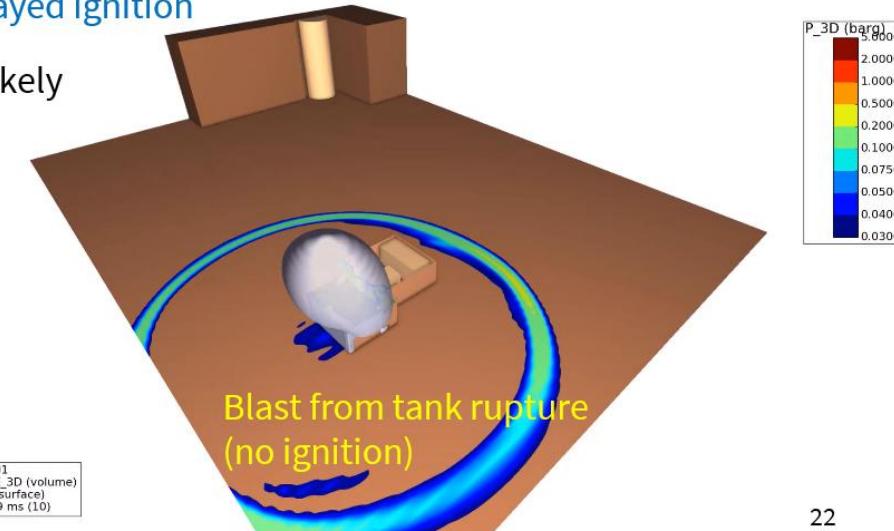
“Low pressure composite transport unit” was exposed to blast/fires and damaged

Significant flame exposure can lead to tank rupture

- Rupture could give 33-45 mbar at 65m distance (CFD predicted ~10% weaker than first explosion)

- Immediate ignition due to fire or tank rupture, delayed ignition less likely
- Car tank rupture tests in fires indicate combustion effect is limited

Vessel burst	Distance to pressure level			Pressure level	Distance
Safety distances and loads	1 barg	0.2 barg	0.05 barg	0.1 bar	65 m
Distance	10.68 m	26.65 m	61.66 m	39.04 m	0.045 barg
Pressure impulse	270.2 Pa s	120.2 Pa s	56.25 Pa s	81.7 Pa s	54.0 Pa s
Pressure duration	5.80 ms	12.91 ms	23.21 ms	16.52 ms	24.20 ms

These scenarios must be prevented by tank design and protection

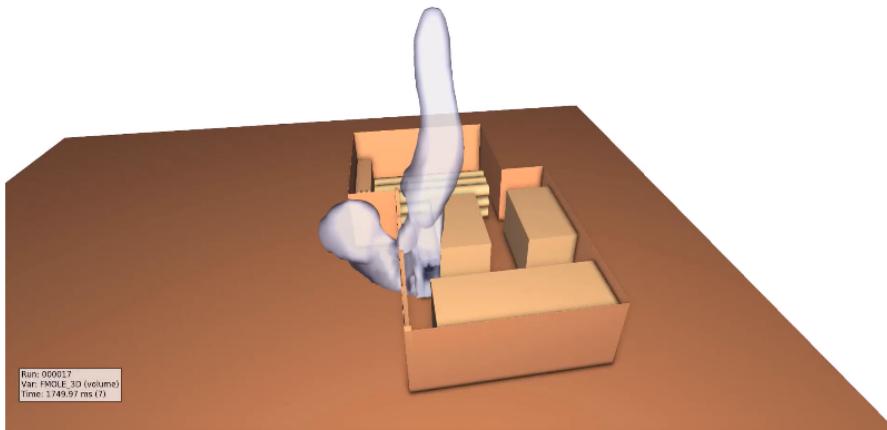
CFD dispersion case simulated with partially porous fence

People outside porous fence would be exposed to flames and pressures twice as high

- ⇒ Increased ventilation is an important measure for very confined modules where small releases of hydrogen can accumulate.
- ⇒ For a site like Kjørbo it is however NOT advised to replace solid fences with porous walls. This would potentially expose people outside the site to flames, projectiles and pressures, and will have an insignificant effect on risk for hydrogen scenarios as large releases outdoor will within moments seek upwards due to buoyancy.

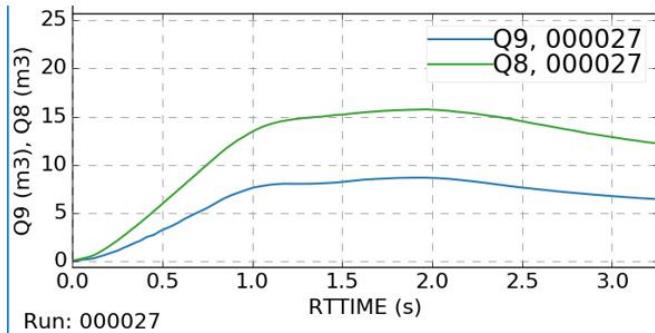
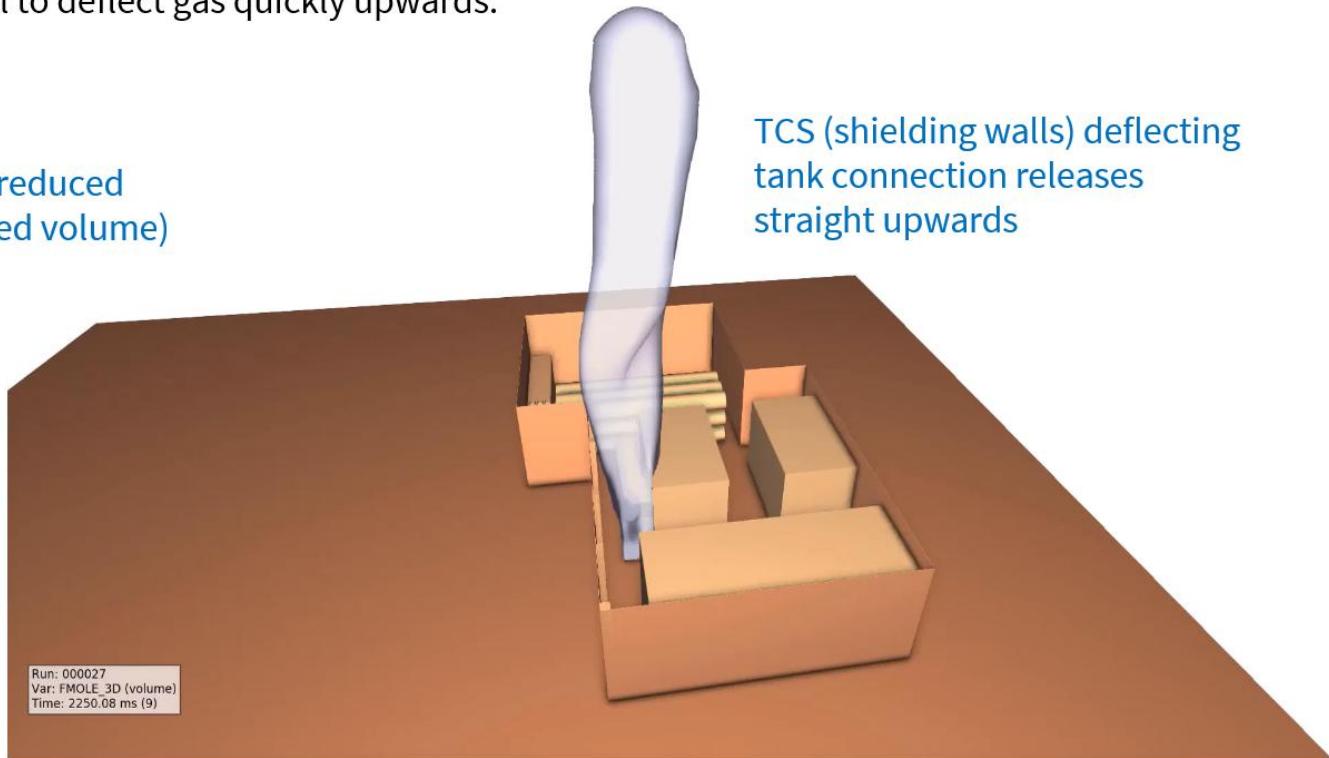
All outdoor releases with major accident potential are normally related to storage

- Cloud sizes less than half, could be further reduced
- Ignition less likely in TCS (rich gas, controlled volume)
- Assumed low likelihood for DDT

⇒ Consider implementing a TCS (tank connection space) solution similar to what is standard on gas fuelled ships. This space shall safely collect and vent accidentally released gas. The simplest version of a TCS would be 4 vertical shields around tank connections and nearby instrument panel to deflect gas quickly upwards.
